Close Call Incident  
Indianapolis Fire Department  
January 27, 2015

**SIIT TEAM  
INVESTIGATION**

The following is a portion of the IFD Significant Incident Investigation Team’s report concerning the CNG Propelled Republic Services Garbage truck explosion on January 27, 2015. This incident has been deemed a “near miss” or “close call”.

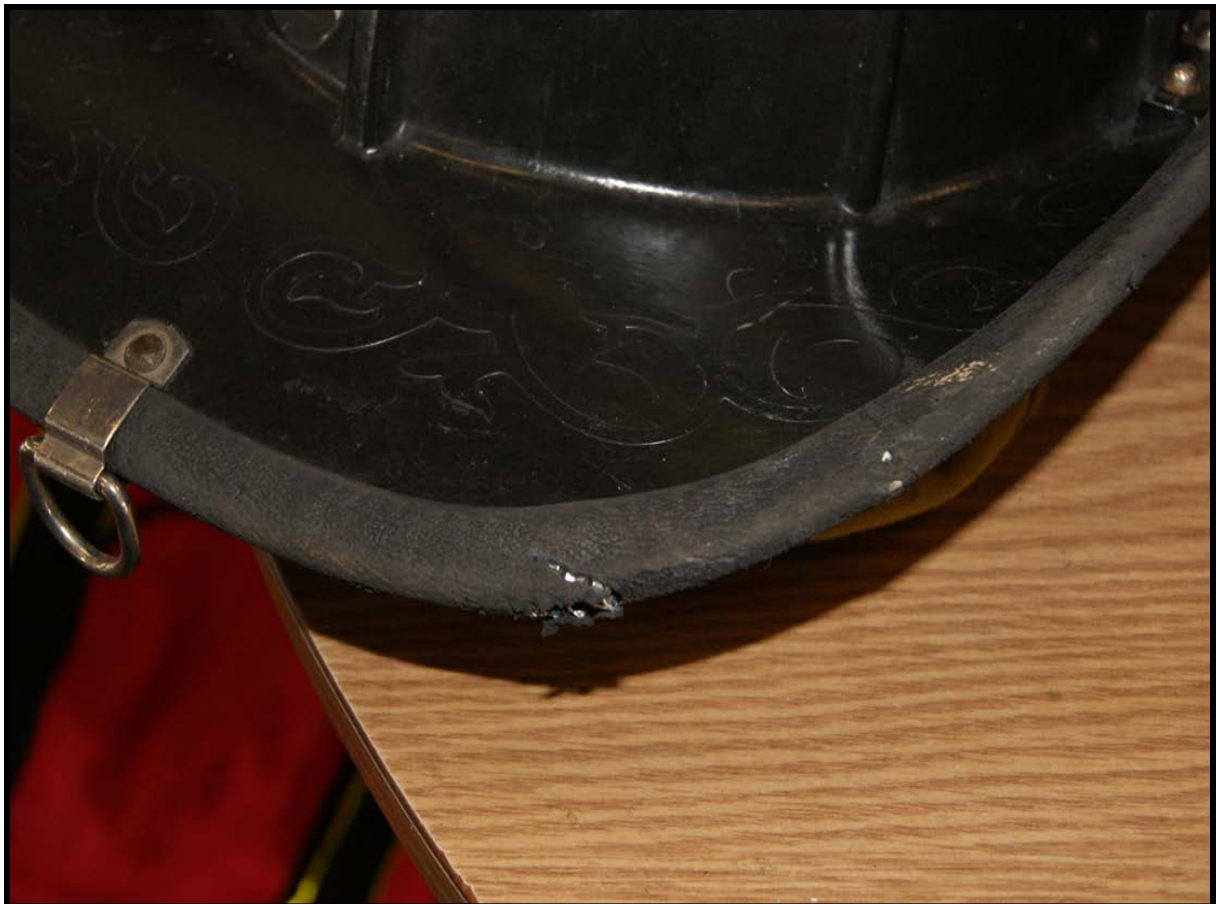
Slight Helmet damage of injured firefighter.

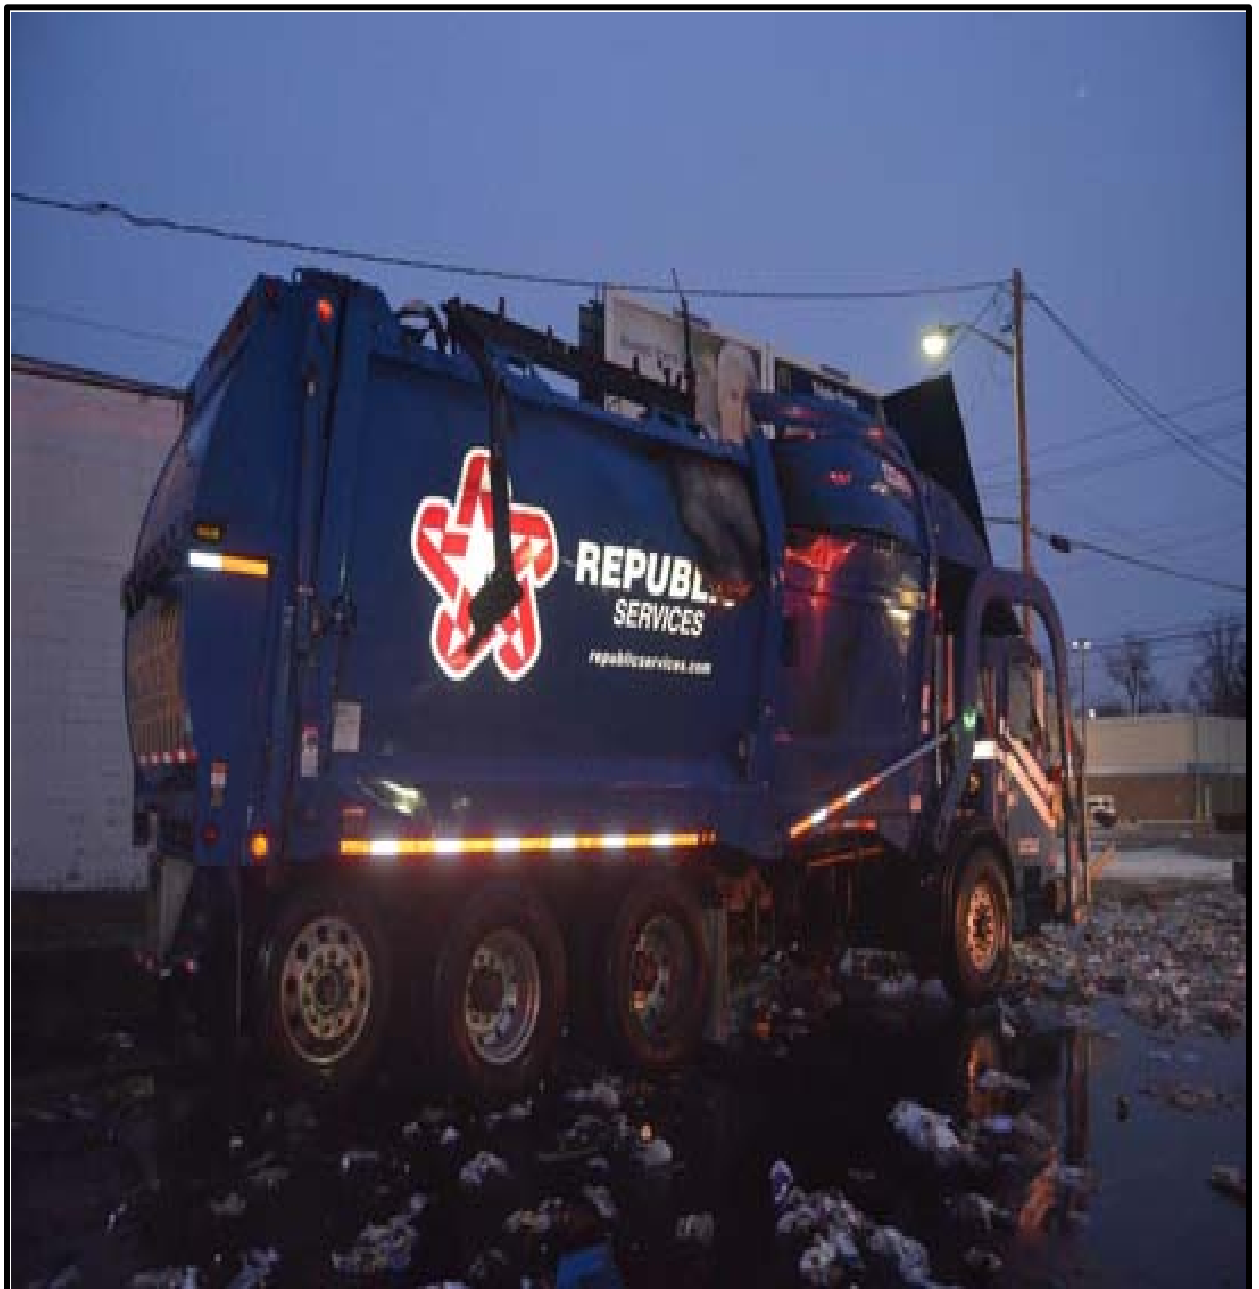
Passenger side of damaged truck at the scene.

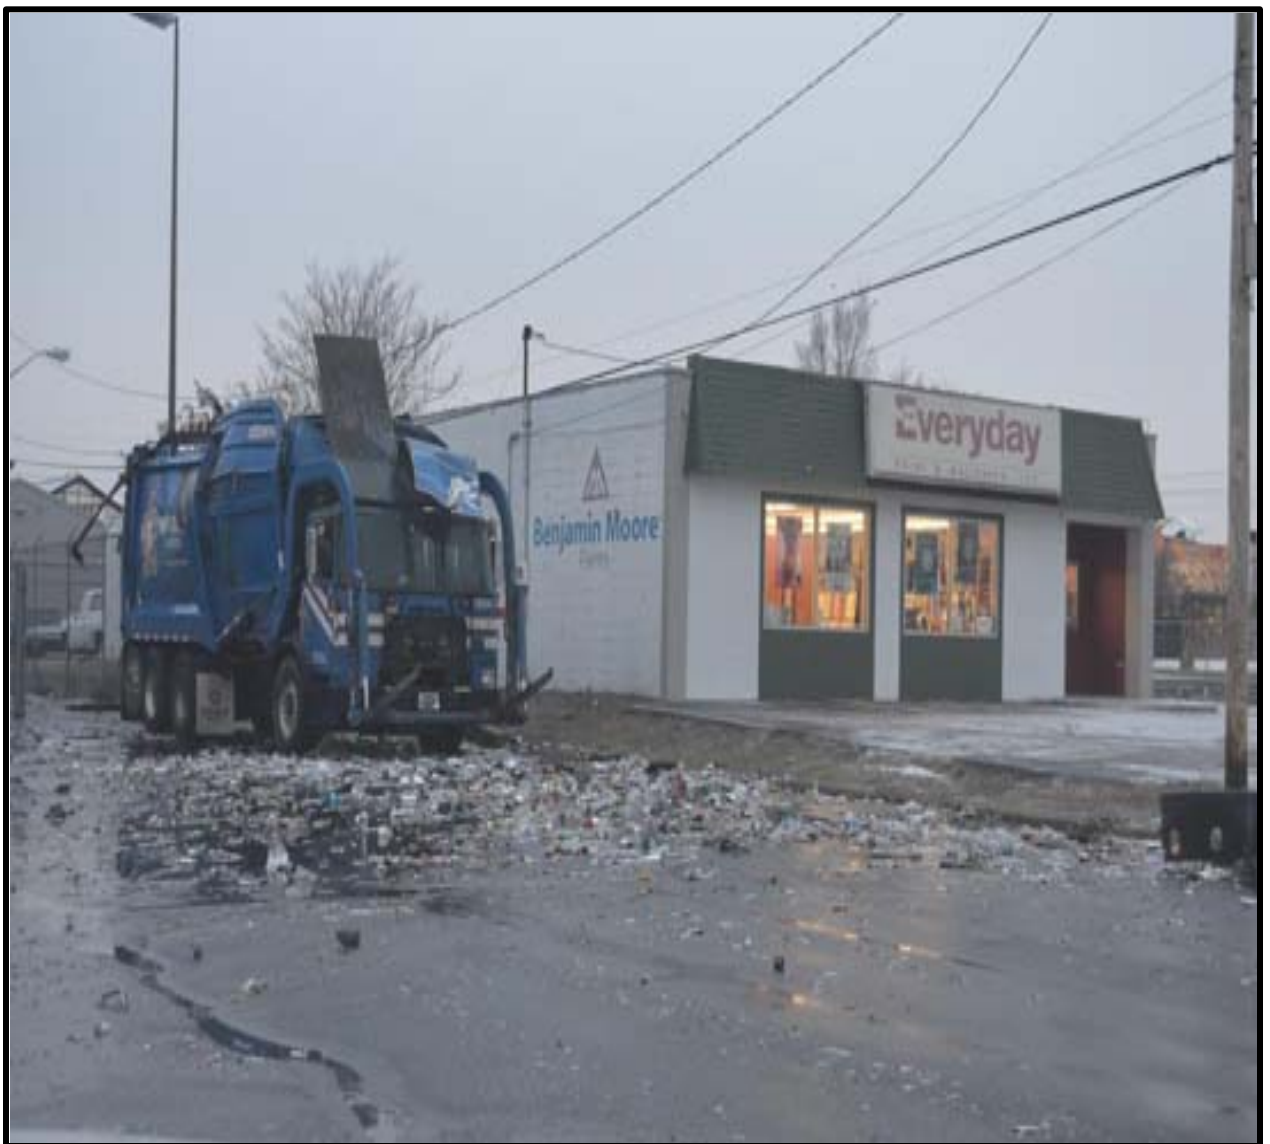
Passenger side of truck with  
double-walled hopper  
bowed out.

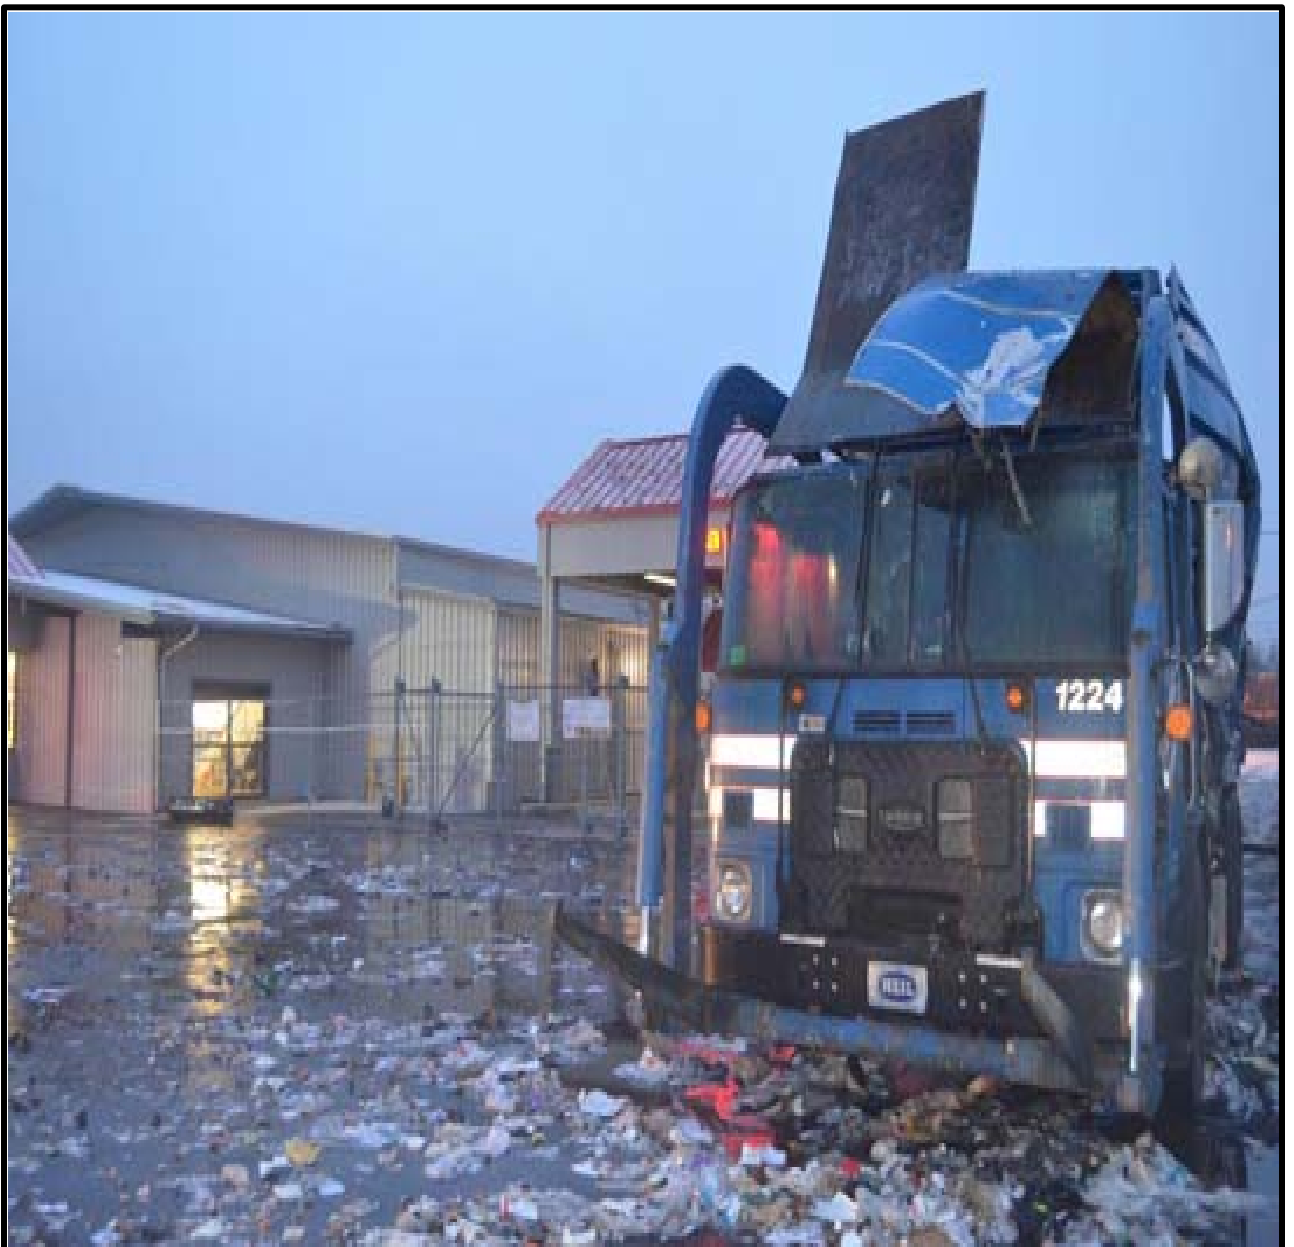
Front of truck with metal cab-guard bent forward.

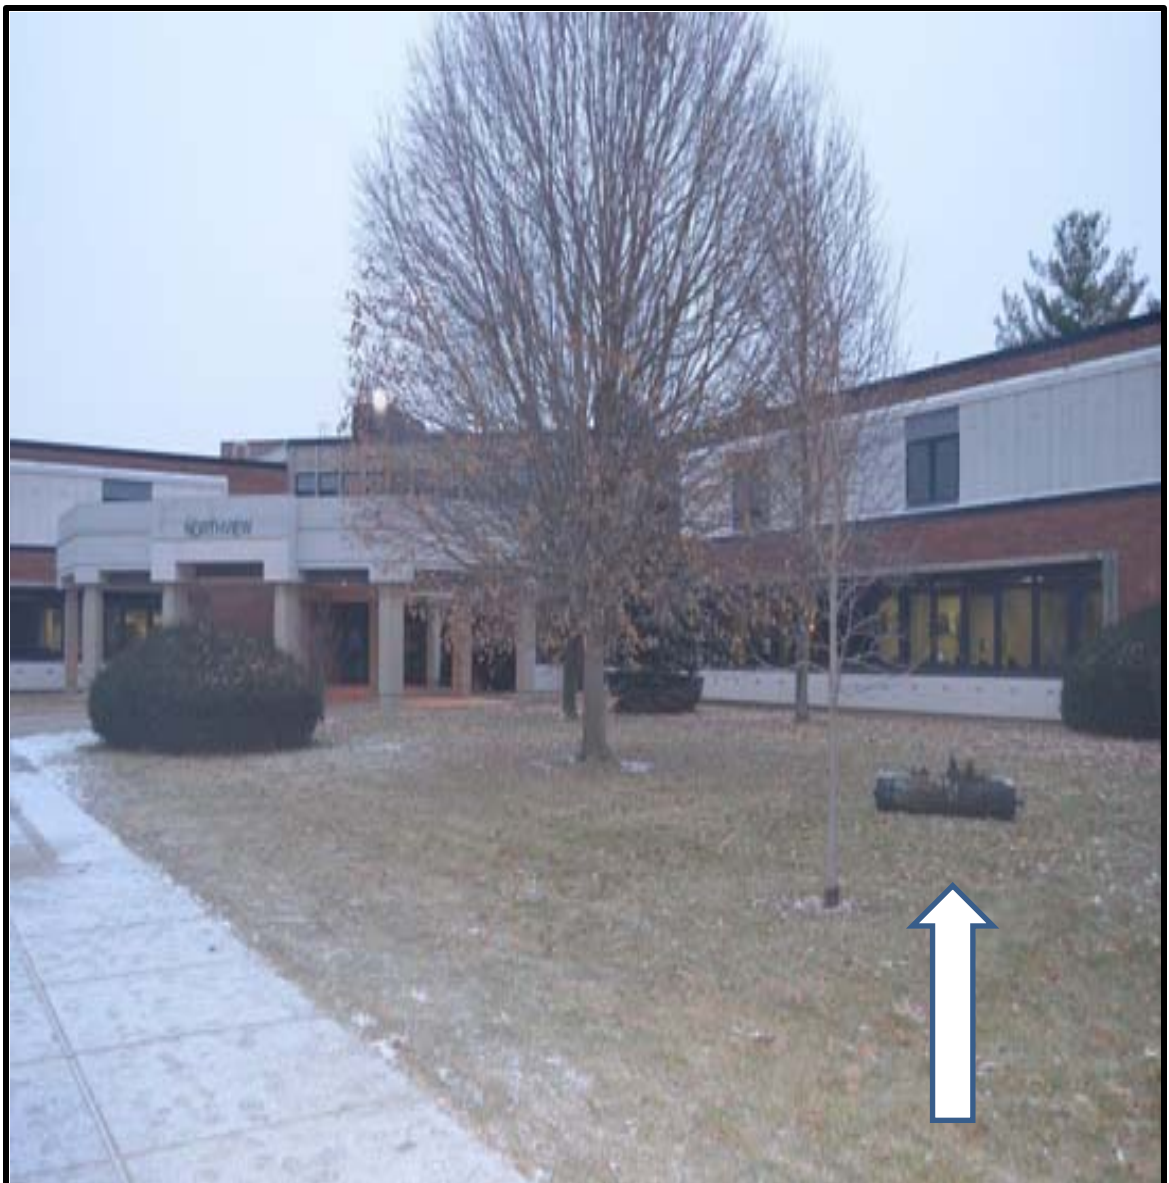
Cylinder located in front of  
Northview Junior High  
School after traveling over a  
quarter-mile.

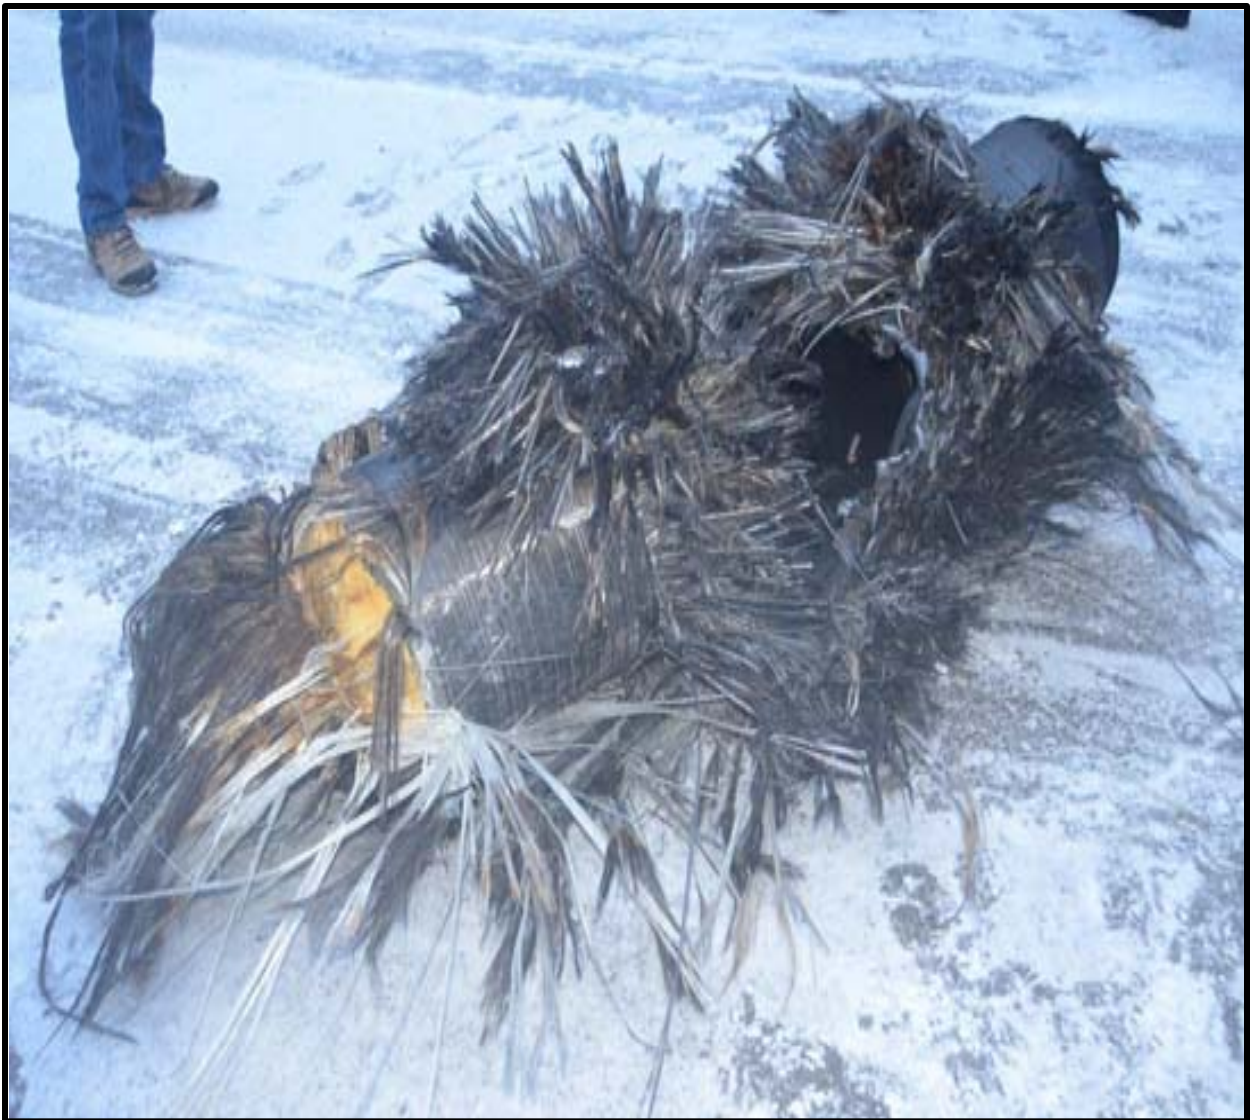
Exploded Type-4 CNG cylinder at the scene.

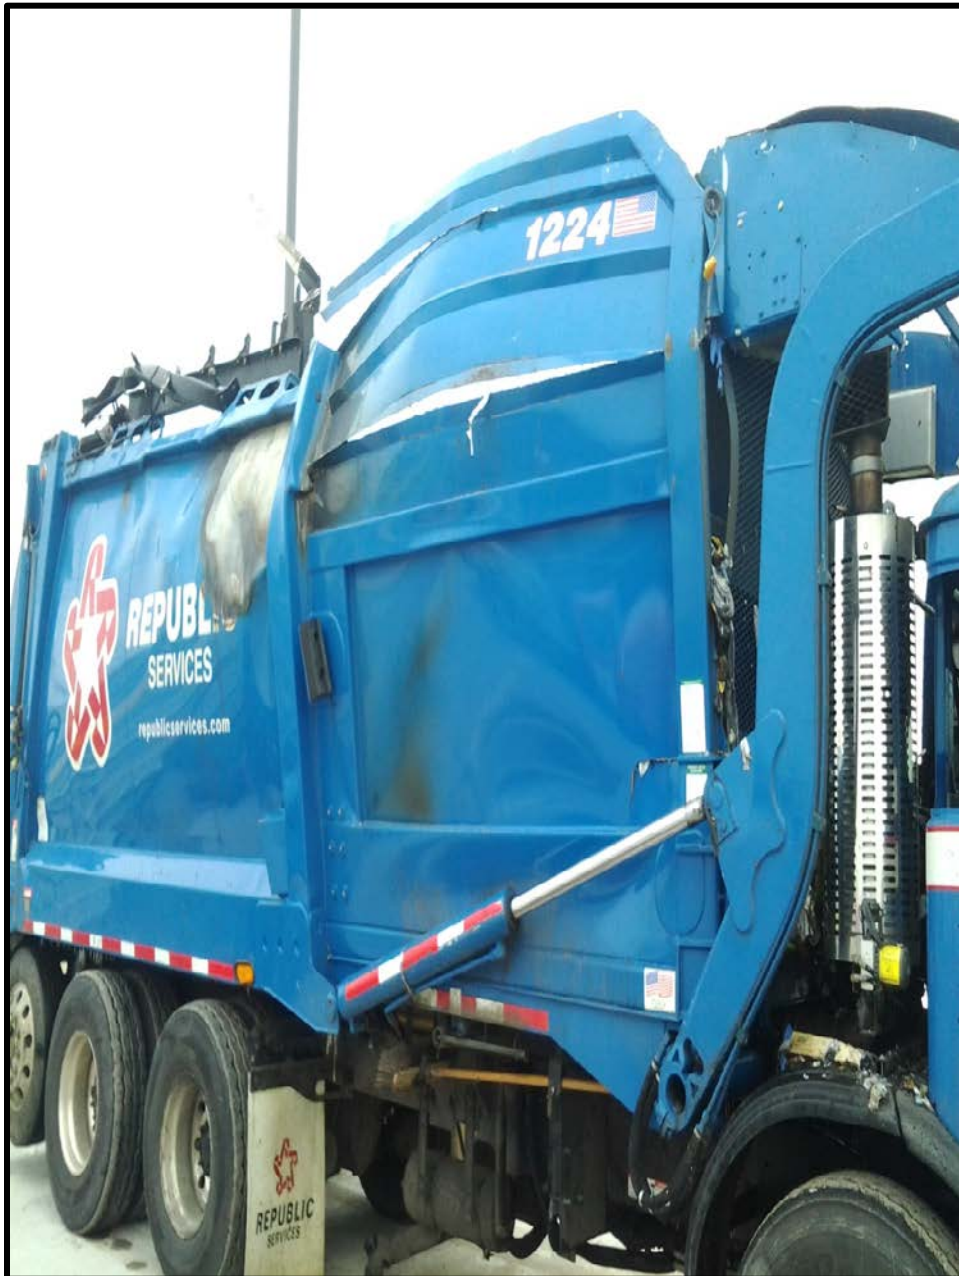
Passenger side of truck with  
double-walled hopper  
bowed out.

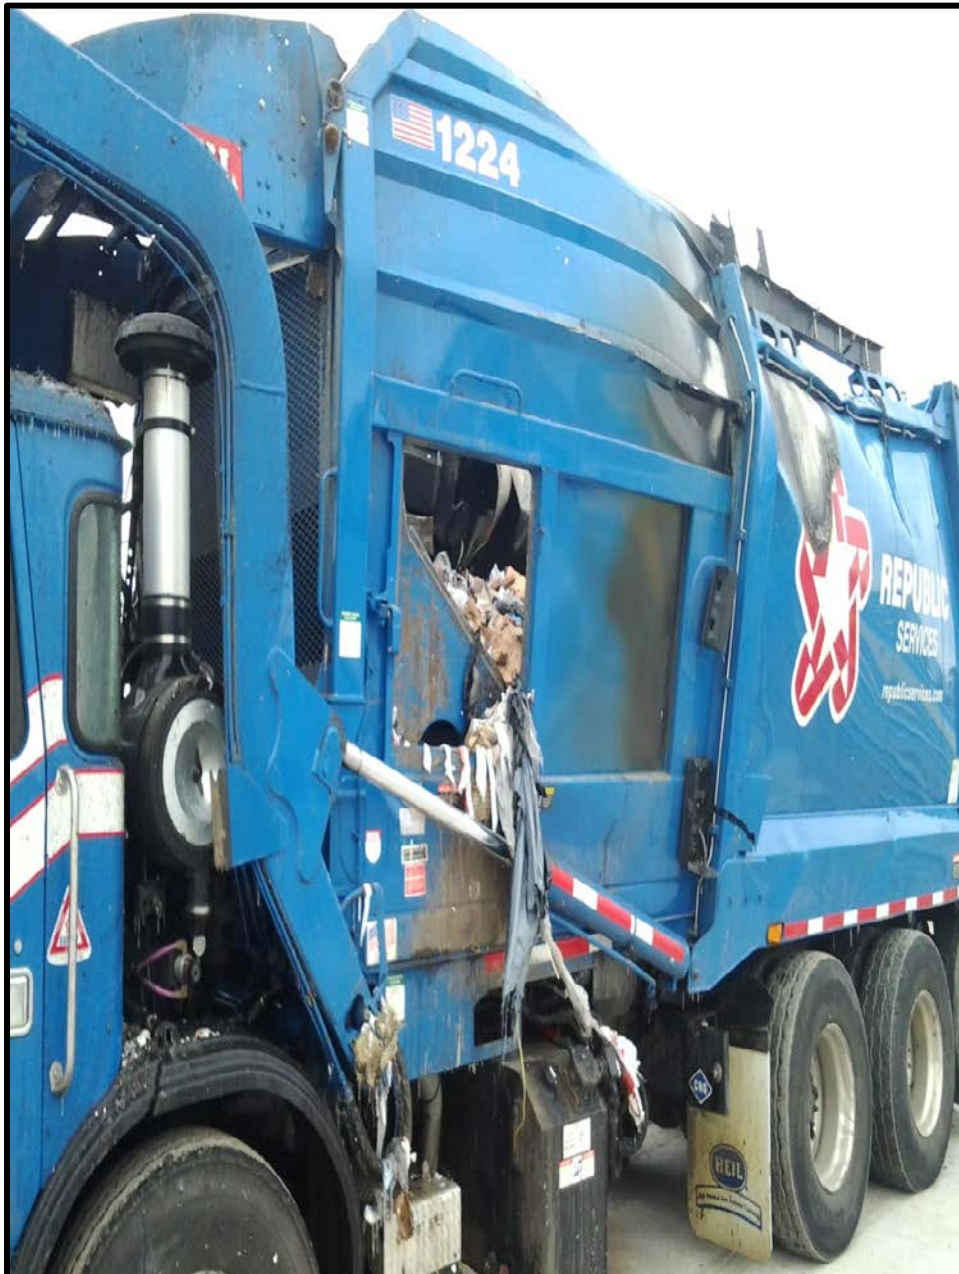
Driver's side of truck with double-walled hopper and steel frame bowed out.

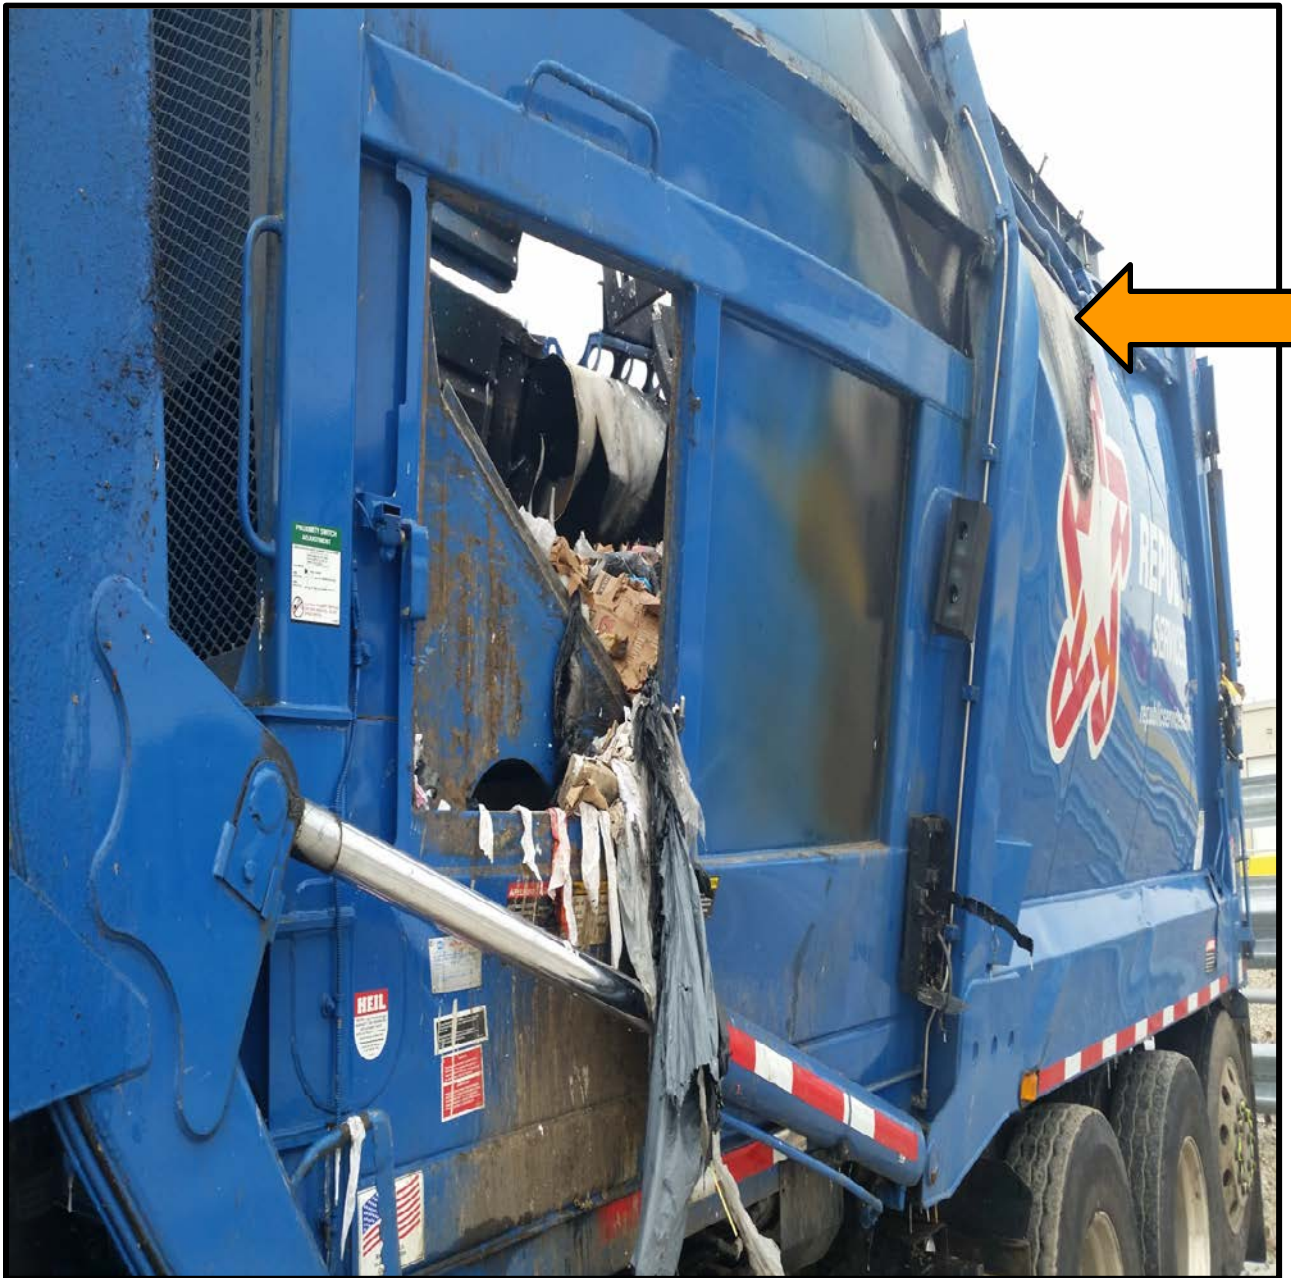
# Driver's side damage

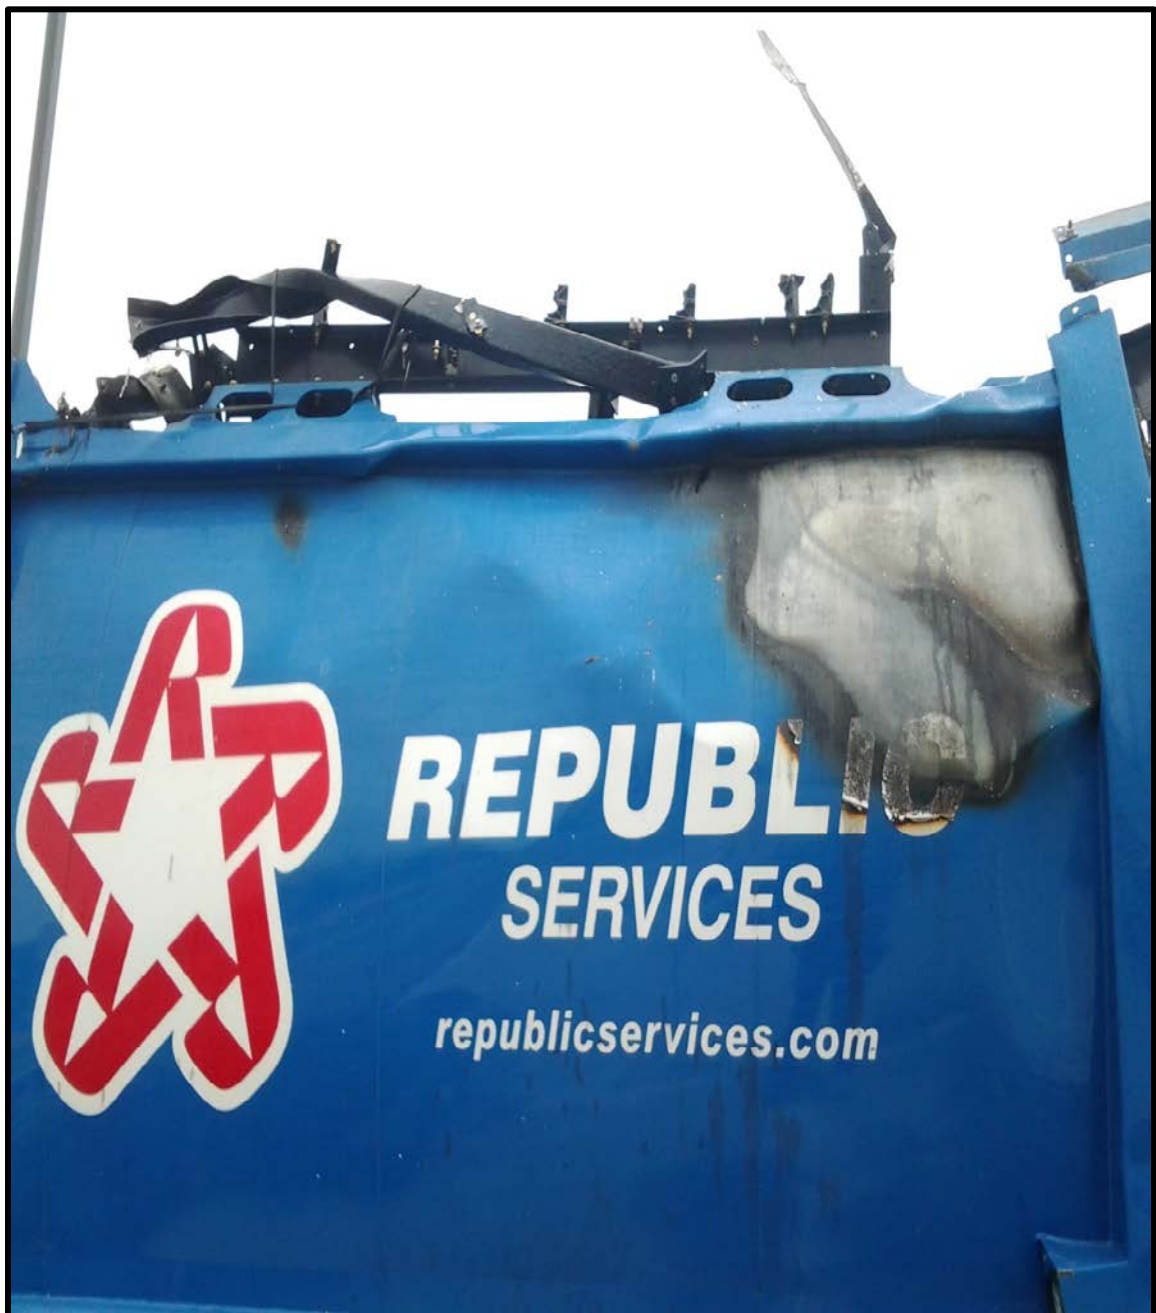
# Location of remaining frame rails of fuel cells (cascade POD)

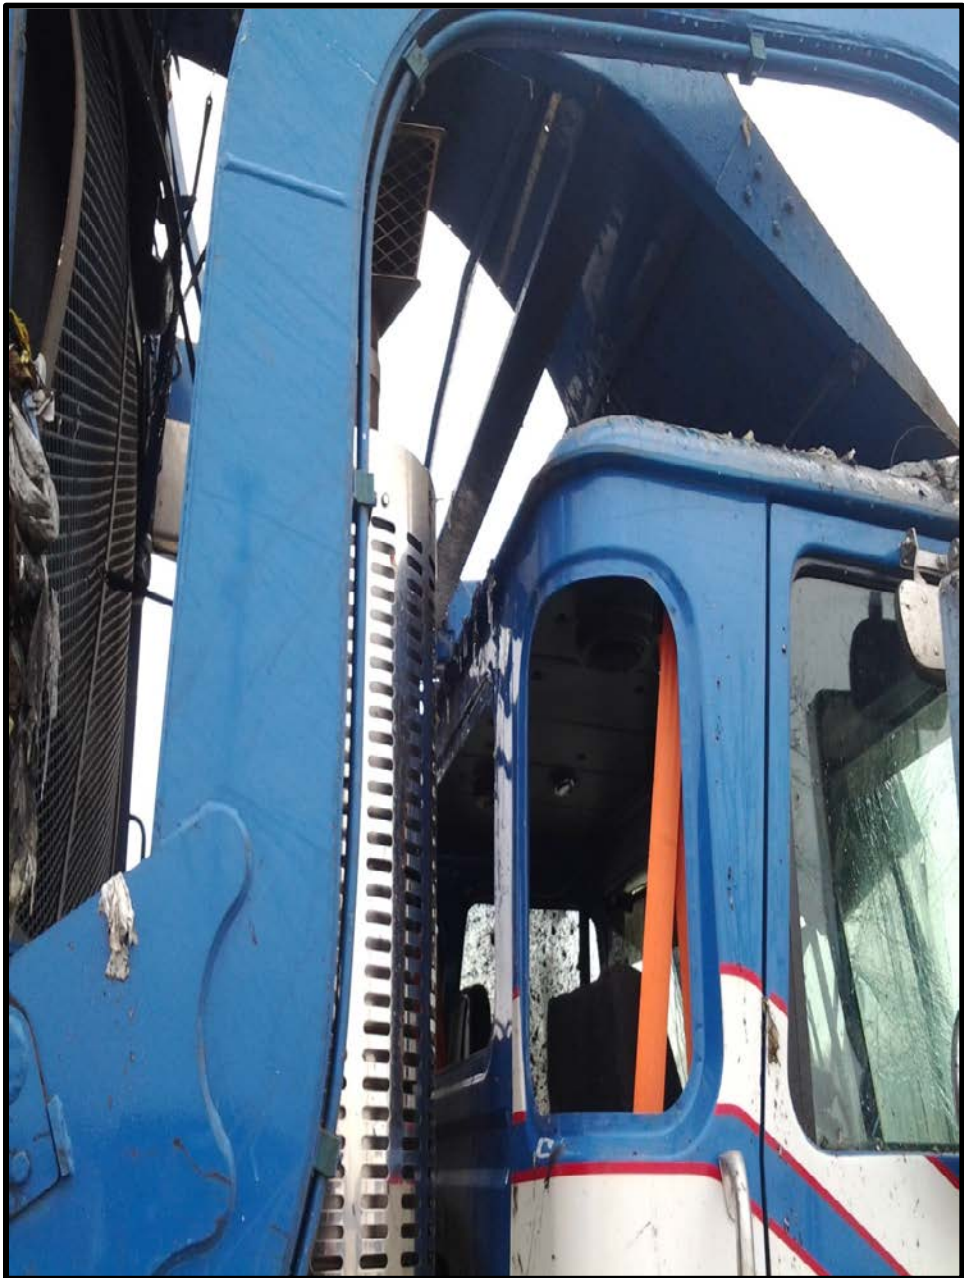
# Cab windows shattered

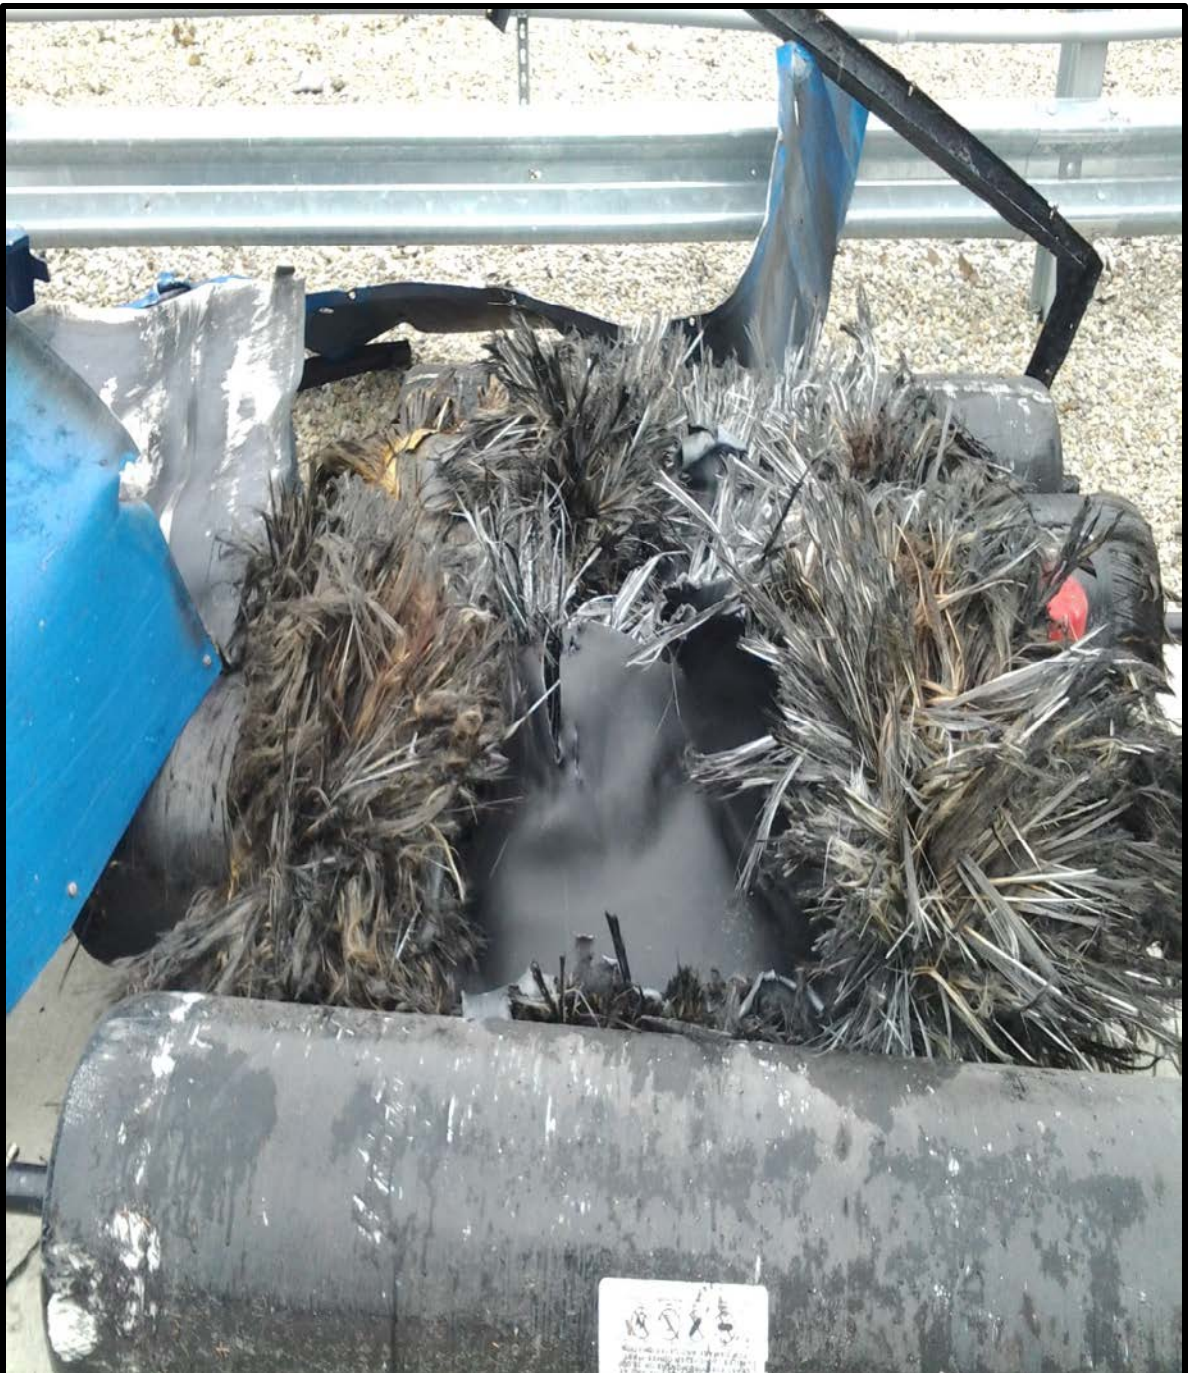
# Exploded cylinders

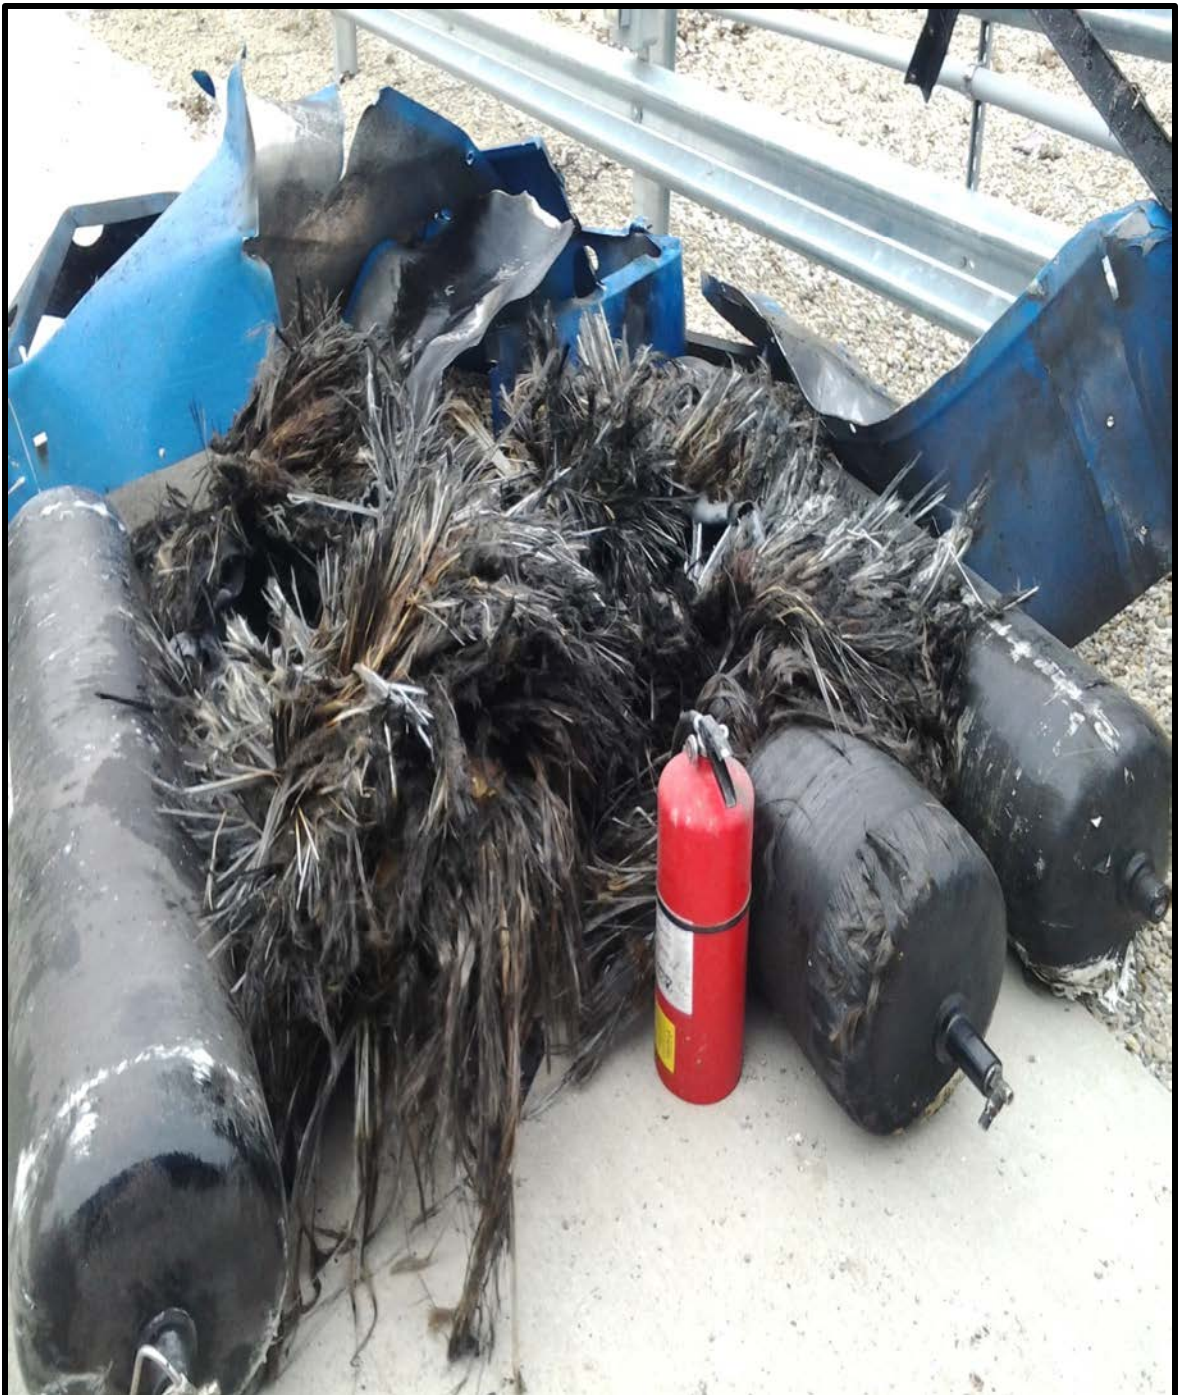
# Damaged cylinders

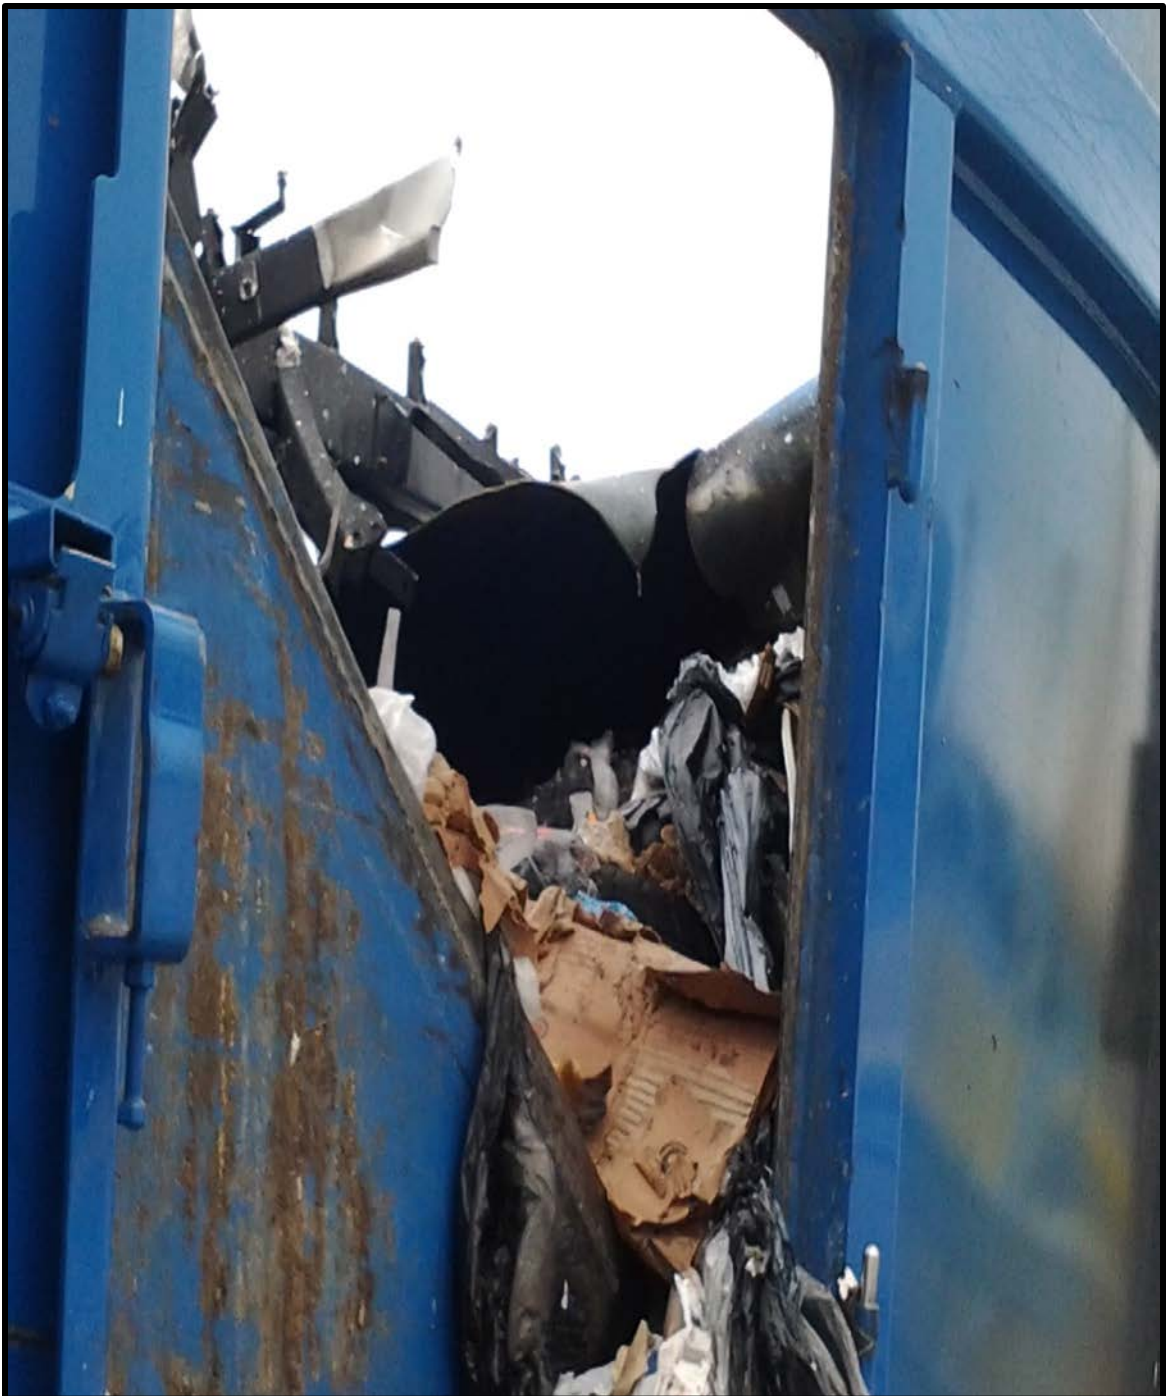
# Damaged hopper and fuel cell frame work

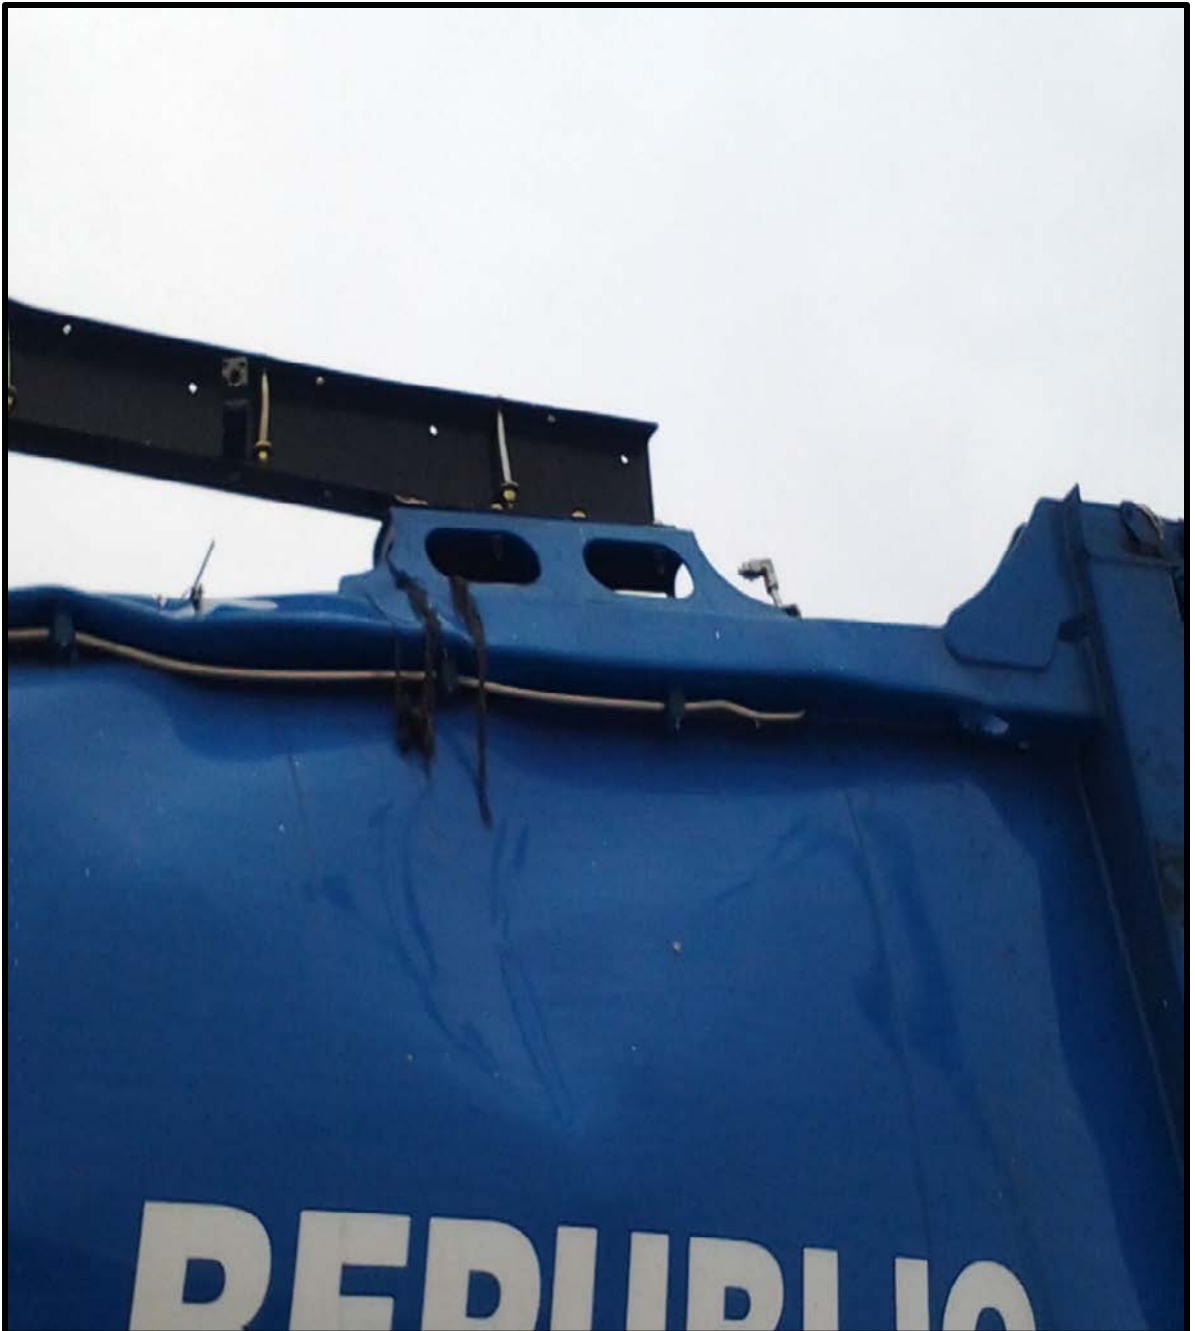
# Exposed fuel line and remaining fuel cell frame work
