Close Call Incident  
Indianapolis Fire Department  
January 27, 2015

**SIIT TEAM  
INVESTIGATION**

The following is a portion of the IFD Significant Incident Investigation Team’s report concerning the CNG Propelled Republic Services Garbage truck explosion on January 27, 2015. This incident has been deemed a “near miss” or “close call”.

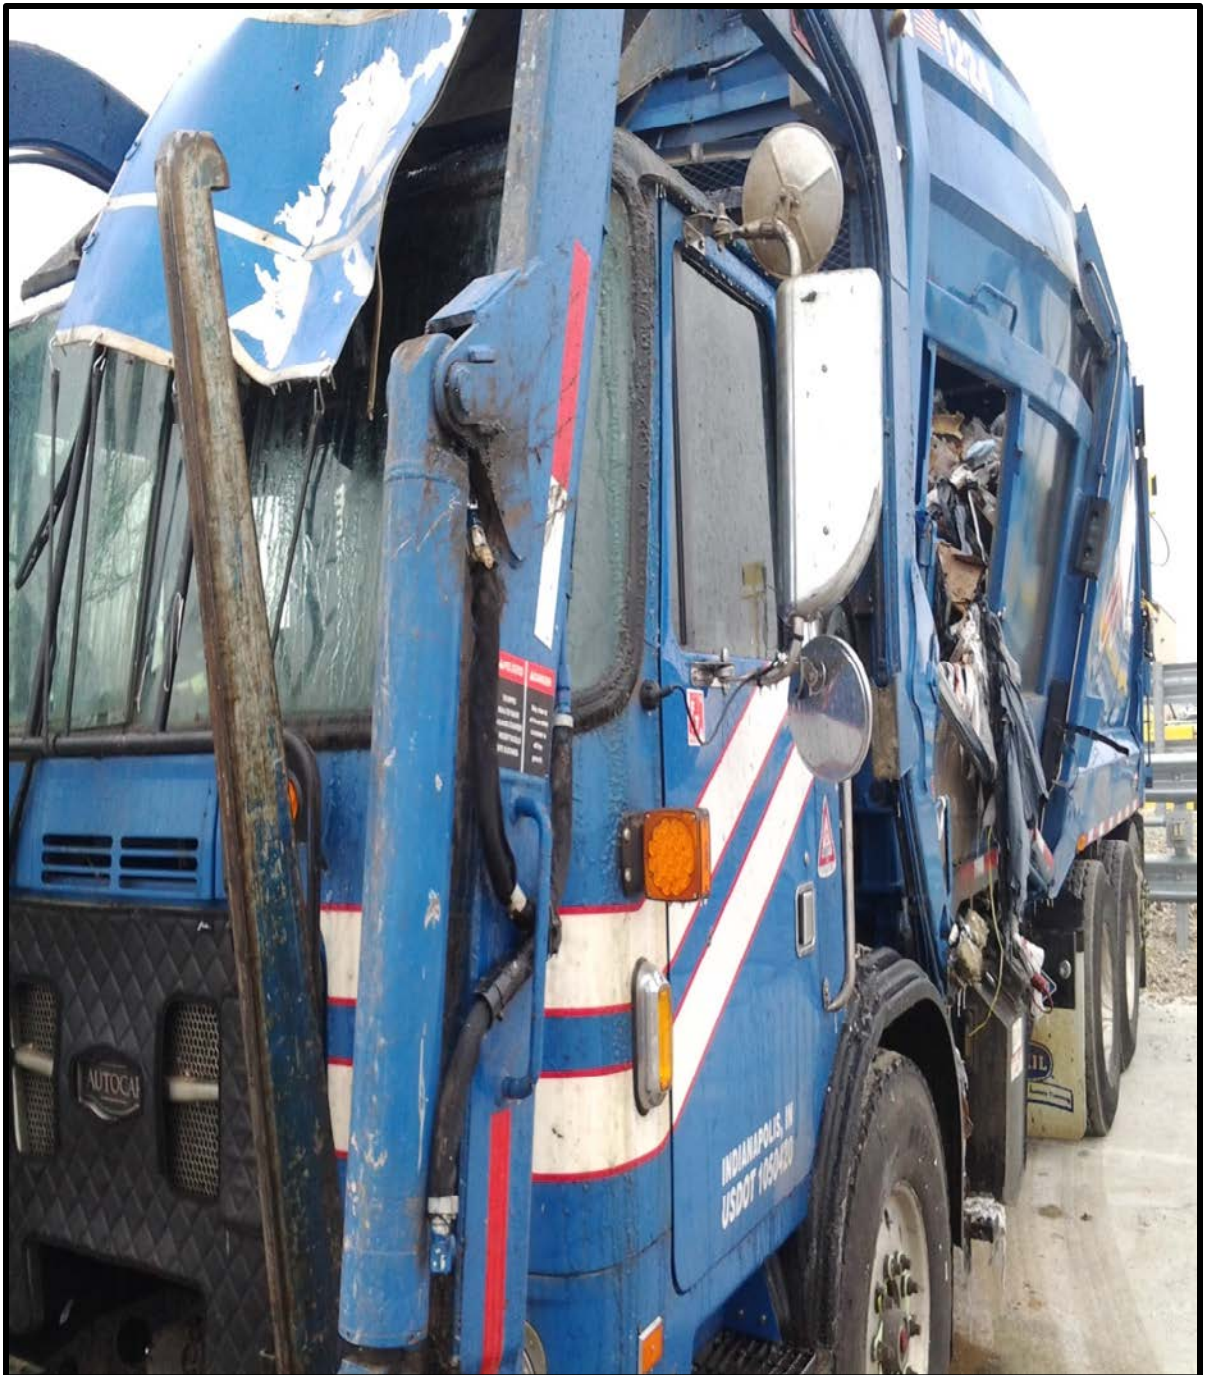
# Bowed-out body and hopper

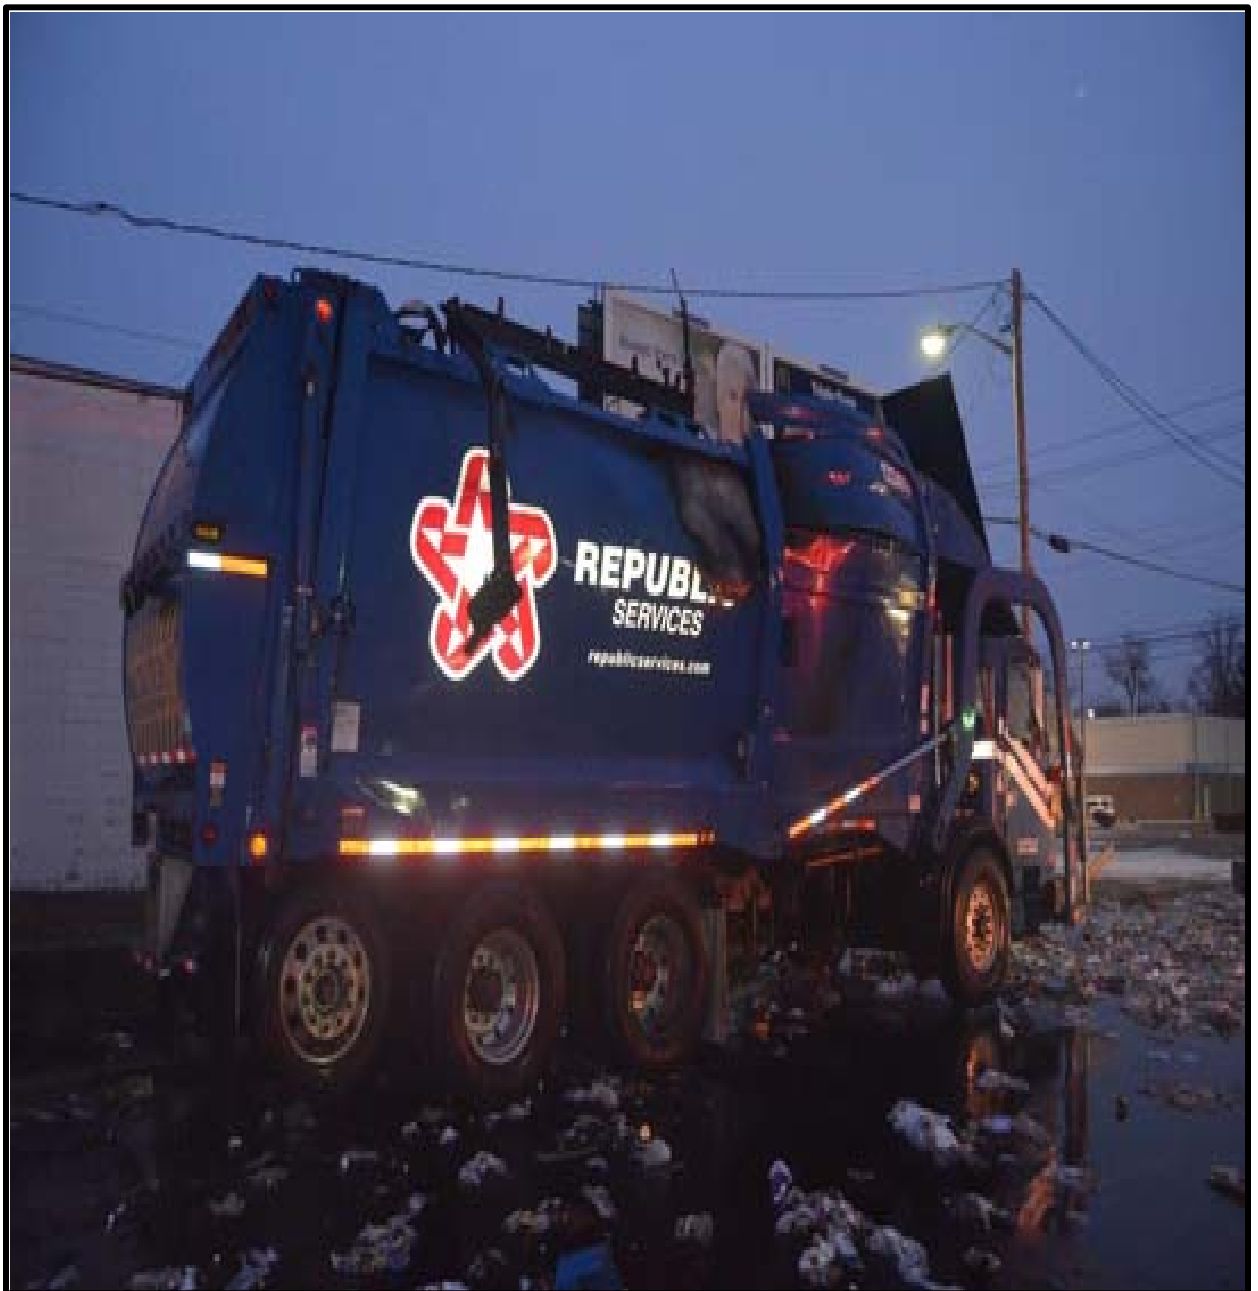
Example of truck after explosion with extensive damage.

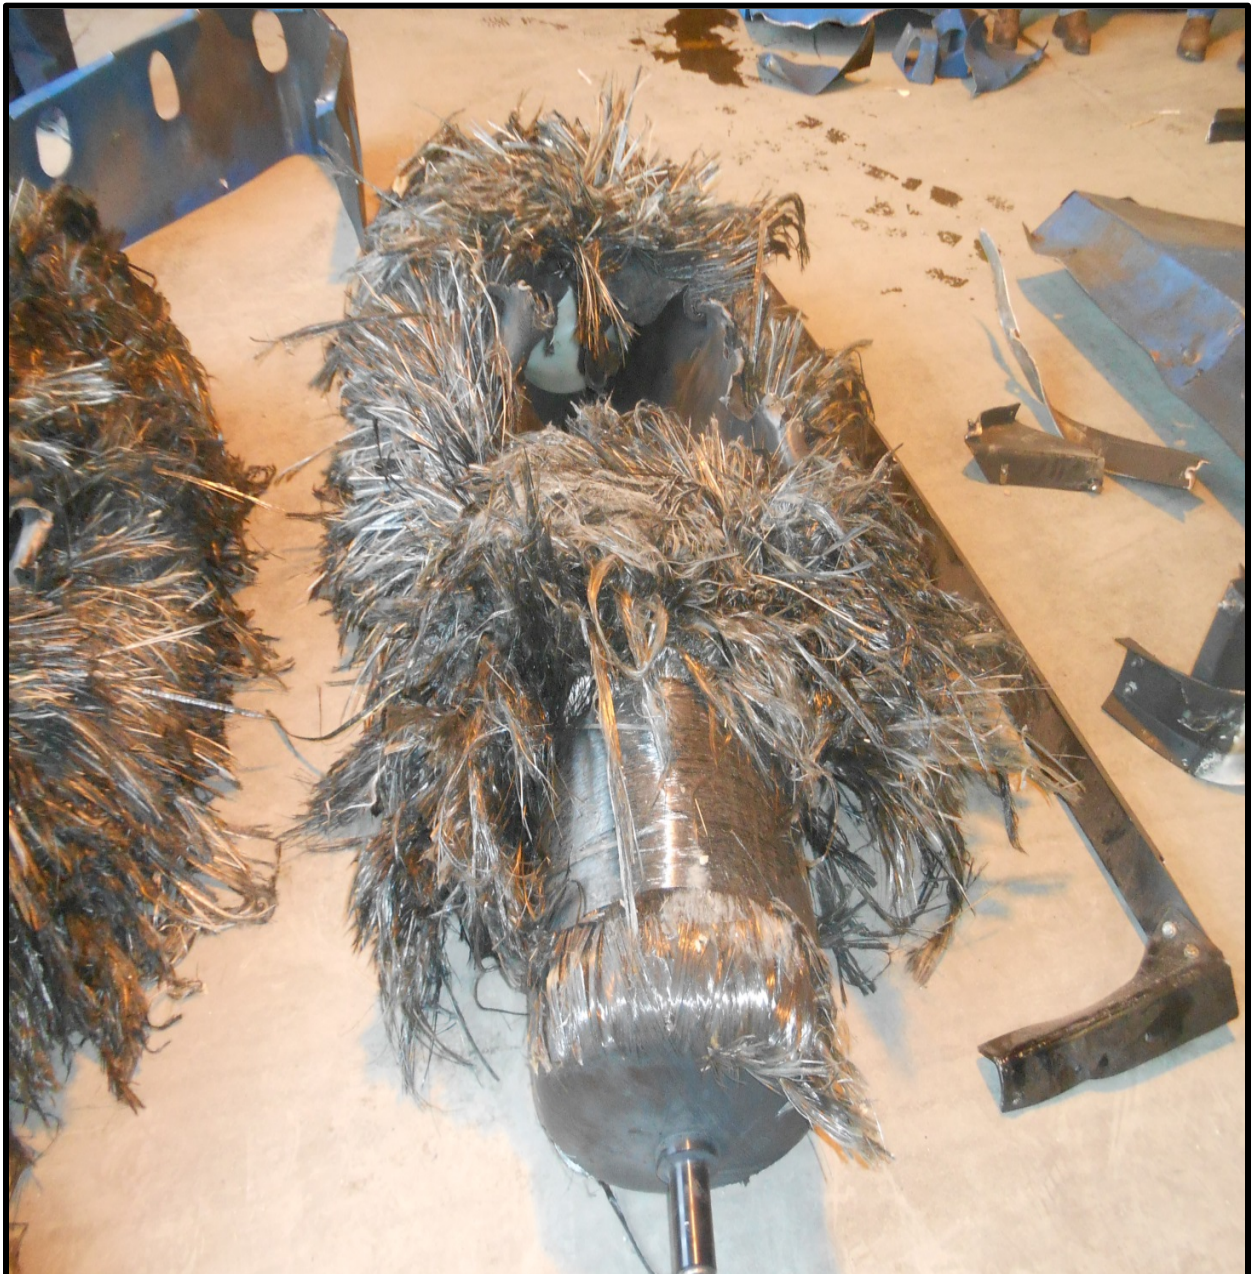
Exploded cylinder exposed to heat near the middle of the tank.

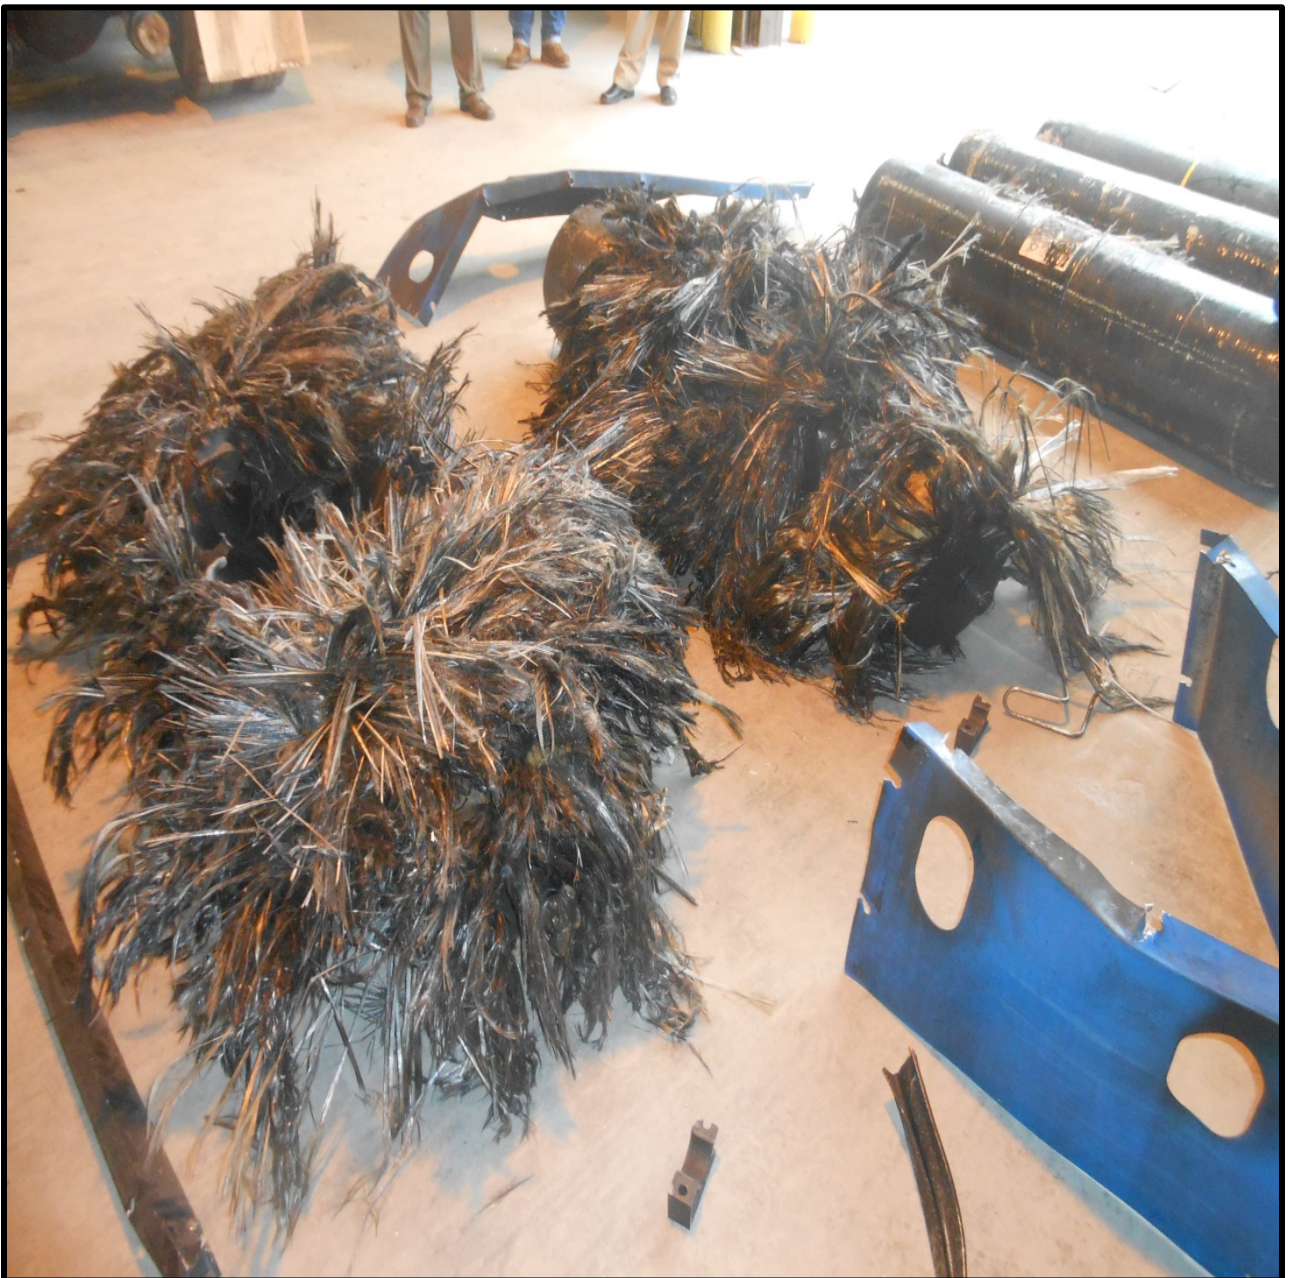
The two cylinders that exploded.  
Both failed near the middle of the  
tanks, it is presumed in the area of  
flame impingement.

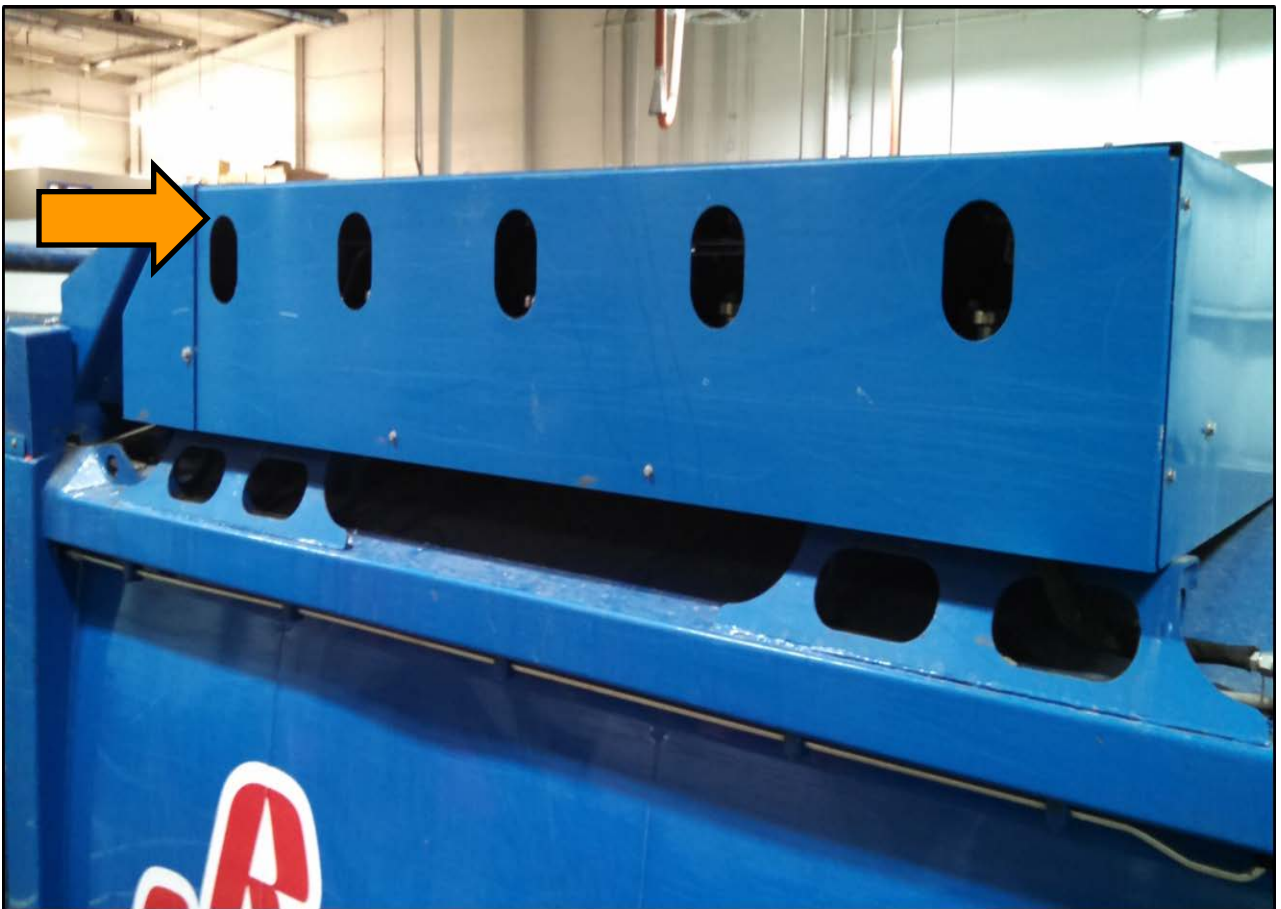
The cylinder PRDs are located just inside the cascade cover openings. Did the water applied for cooling interfere with the PRDs ability to open?

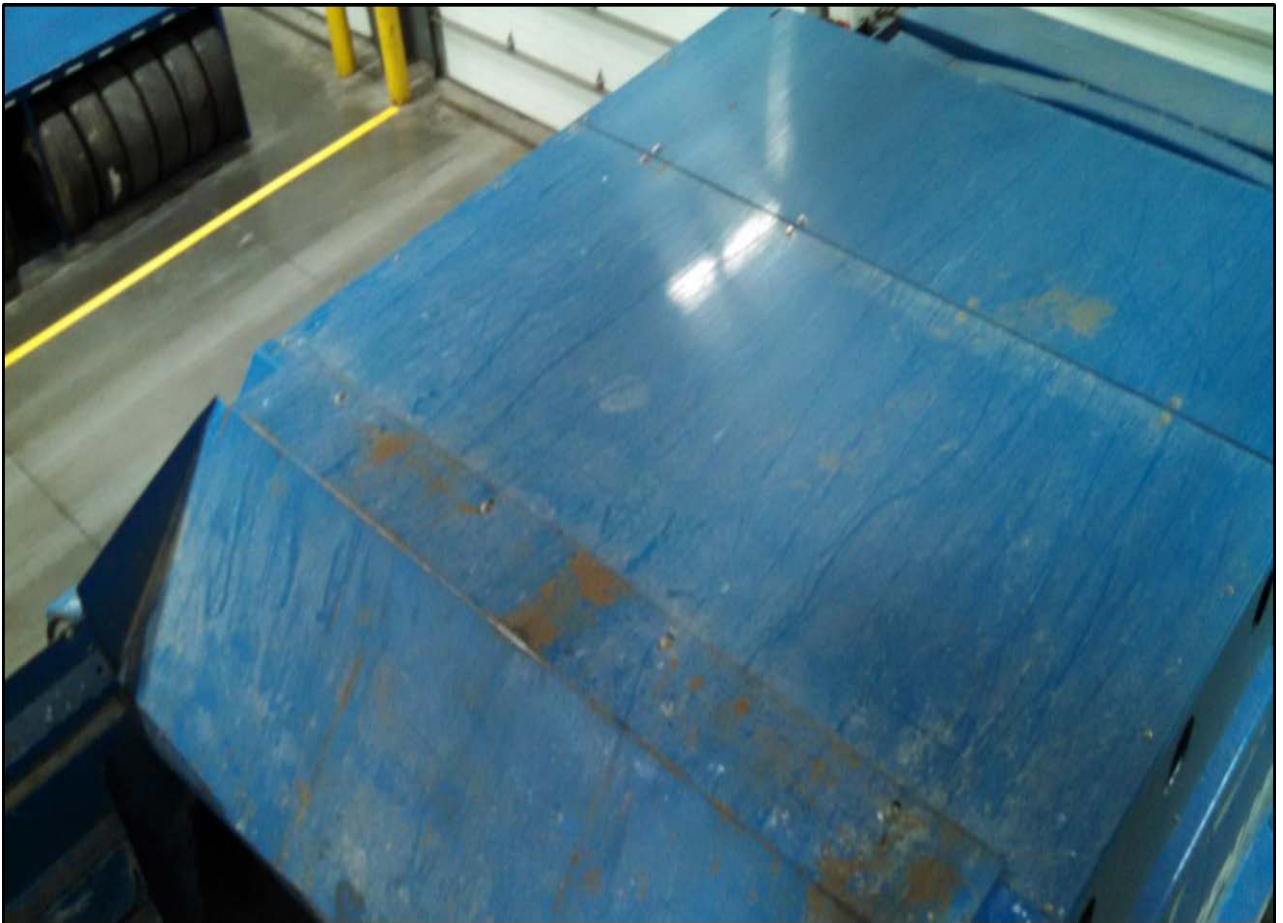
The CNG Tanks/Cascade POD are enclosed by a steel box. This can inhibit cooling by *NOT* allowing water to reach the cylinders?

The top of the CNG Tanks/Cascade POD are enclosed by a steel box. This can prevent cooling?

7. Personnel should be positioned behind apparatus as a shield for precaution after critical functions have been completed.
8. The cascade cover will prohibit effective cooling of the tanks if the tanks are exposed to direct flame contact.
9. Provide Department wide training concerning recognition of these types of vehicles and the dangers posed by them to responders and the public alike.

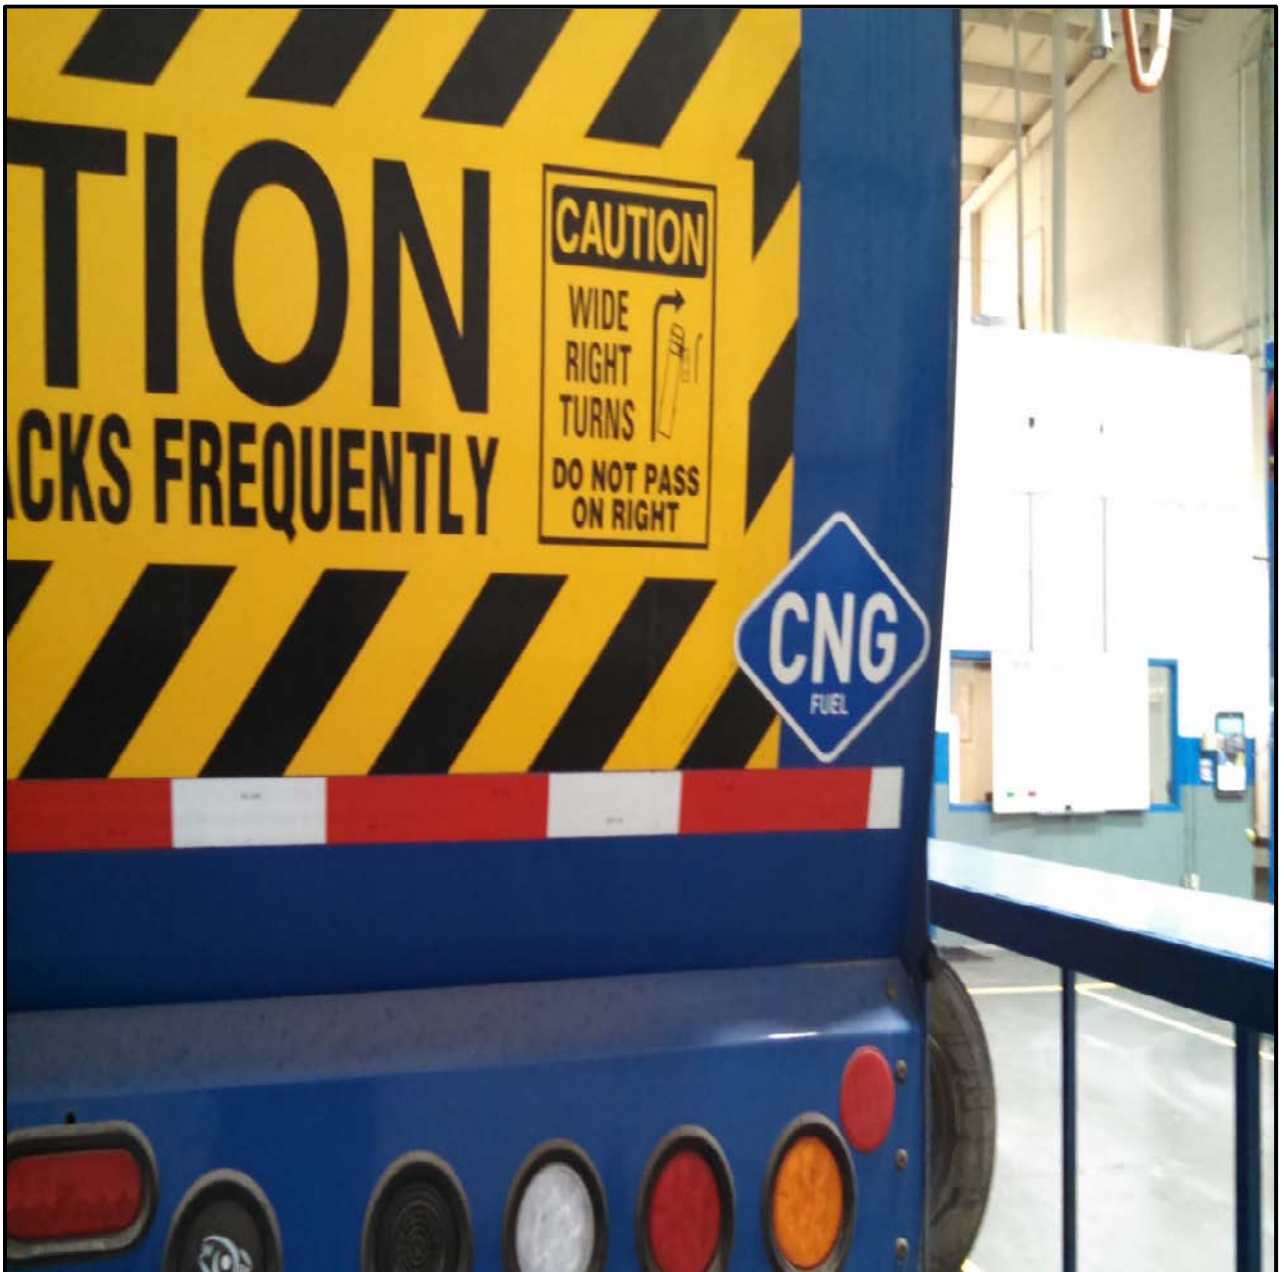
# CNG placard (camouflaged?)

There was some confusion as to what type of fuel (Gas) was in the tanks and where the tanks were located in relation to the fire. CNG vehicles only require a small, blue, diamond-shaped CNG placard denoting the propulsion system. This was located in the right rear of the vehicle and not readily visible to the crews at hand.
