# New House Fire Hazard: Exploding Attic Stairs

08/28/2013

By Chris Kear and Jerry Knapp

This article aims to make firefighters aware of a new **hazard** found in **residential fires** and suggests possible **tactical** changes to minimize this new threat to **firefighter safety**.

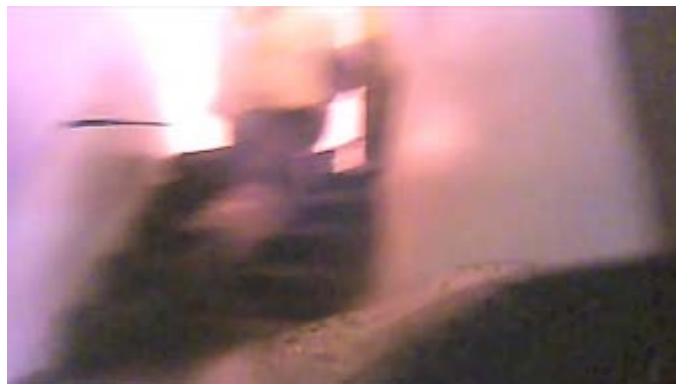
*This screen shot shows the gas cylinder lodged in the wall on the left-hand side:*

Firefighters behind me saw (and which was captured on video) what we later determined to be a gas spring from the pull-down stairs apparently become over-pressurized and launch from the pull-down attic stairs, shoot past and behind me, and imbed into the wall on the main staircase. A concrete fire wall behind the sheetrock stopped the cylinder and left it imbedded in the wall.

First, if the gas springs are exposed to heavy fire and the attic stairs have sagged, apply water from the bottom of the main stair case as you would to any pressure cylinder that has flame impingement, cooling it from a distance. This puts you at as great a distance as possible should they explode. Time, distance, and shielding are your allies.

Second, if you have to open the pull-down stairs to gain access to the attic use a hook and position yourself behind the stairs or on the hinged side. The pull-down stair ceiling panel will provide some shielding for you. However, bear in mind that the struts are on the sides of the pull-down unit, so protection is minimal. A short utility rope can increase firefighters' safety by allowing the firefighter that is pulling down the stairs to be further away or even in an adjacent room behind protective cover. Attach your utility rope to the ring, chain, or rope that occupants use to pull the stairs down.

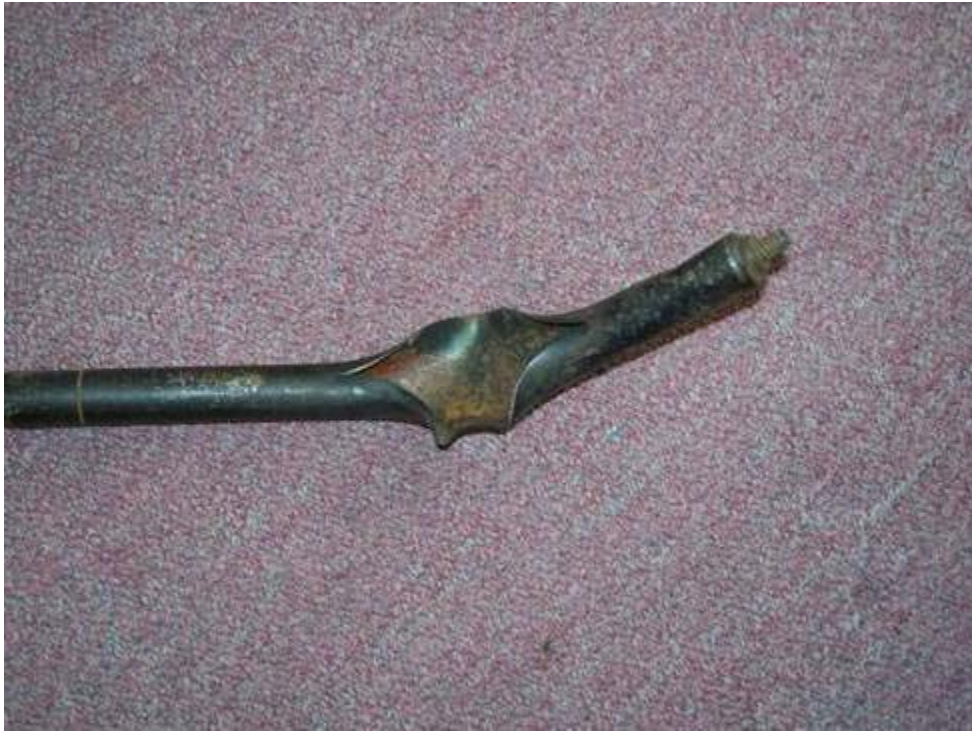
The first explosion was the failure of a gas spring cylinder that apparently remained on the pull-down stairs. We found this strut still attached by one end during overhaul. The picture below shows how much energy was released when it exploded.

*(1) Note the threaded ends of the strut are still intact and not damaged. The bend in the strut leads us to believe it is possible that it expanded while still fixed to the unit and was under excessive pressure with the cylinder wall seam failing as the weakest point.*

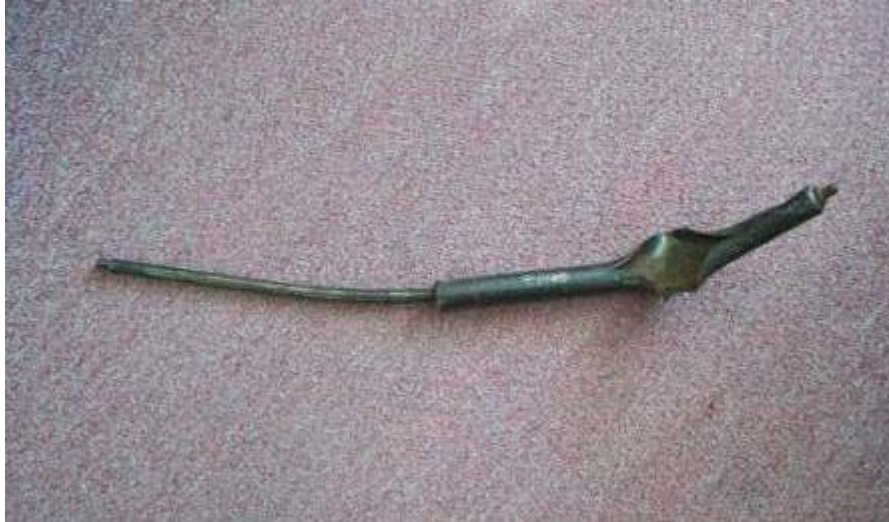
*(2) Complete view of the first gas spring that exploded. The rod is still in place and the threads intact on both ends. Did this force the stairs downward, as reported by first in firefighters? If springs held up the pull-down stairs, heat may have caused them to lengthen and sag. This one remained in place (attached by one end) and was removed by the fire inspector from the damaged pull down stairs.*

It is important to consider the extremely high pressures involved in this device and the additional increases in pressures caused by the heating of the sealed cylinder. Department of Transportation's 49 CFR regulations require the cylinder to withstand four times the working gas pressure it holds inside of it. At a minimum, that is 1,000 psi (250 x 4) and a maximum of 10,000 psi (2,500 x 4). Sudden release of these pressures can and, in this case, did provide a significant amount of thrust to propel the cylinder toward the firefighters.

Although we are speculating, it appears that the first gas spring was fixed in place and pushed open the pull-down stairs when the stroke extended and then became jammed against something. With no other failure scenario—the piston was against the end of the cylinder, providing a reinforced seal—the cylinder casing failed, most likely along a seam. The second (flying spring) apparently had the end fittings melted off by the fire's heat; this heat also increased the gas pressure, failing the seals at the end of the unit, releasing the gas that provided the thrust. These scenarios would account for the metal threads on each end of both springs were not damaged. Therefore, we believe they were released when the end units melted off.

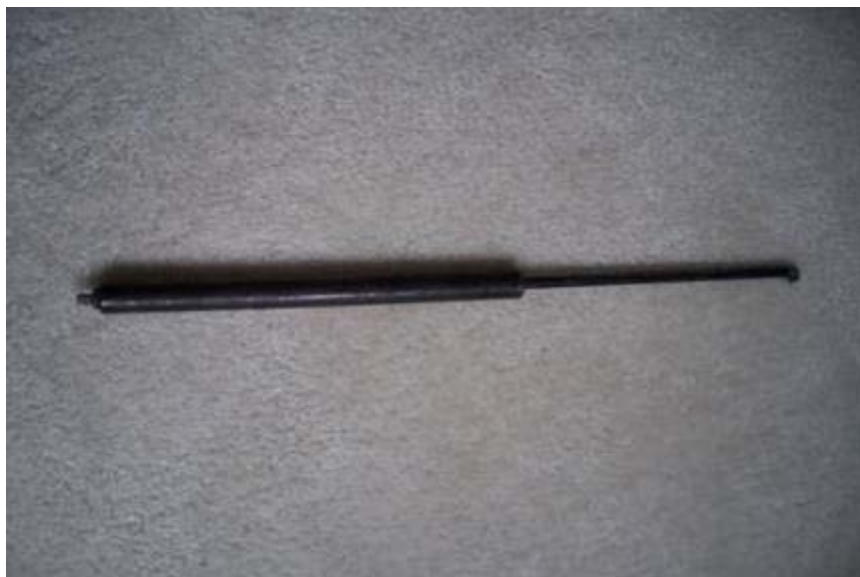
The second gas spring (photo 3) failed in apparently a different way: in a projectile, rocket-like manner. As previously described, it went whizzing behind me and in front of the nozzle man and helmet camera. It was relatively silent; just a short hissing sound. In fact, I did not even hear it over the sounds of the radio, self-contained breathing apparatus (SCBA), and so on. It seems it would have gone completely through the wall had it not been for the concrete block fire wall. Clearly, this projectile could have caused serious injury or death to a firefighter, especially if he was struck in the head or vital area. It flew about 12 feet, launching from the attic opening and coming down and across the main stairs, imbedding into the wall.

*(3) The second cylinder rocketed and imbedded in the wall. The cylinder, the piston rod, and the threaded connections at each end are all intact. The rod moves freely, without resistance, for the length of the throw of the cylinder, but it feels as if the seal at the end of the rod inside the cylinder was damaged and no longer sealed.*

It is not clear why the struts failed in two different ways—one exploding and one rocketing. Both have screw-threaded ends and, apparently, were firmly fixed to the pull-down stairs. It was clear that there were two threats to firefighters: First, the missile hazard of the entire gas spring impacting and possibly impaling/spearing a firefighter. Second is the fragmentation hazard caused by the exploding strut while remaining in place.
