Close Call Incident  
Indianapolis Fire Department  
January 27, 2015

**SIIT TEAM  
INVESTIGATION**

The following is a portion of the IFD Significant Incident Investigation Team’s report concerning the CNG Propelled Republic Services Garbage truck explosion on January 27, 2015. This incident has been deemed a “near miss” or “close call”.

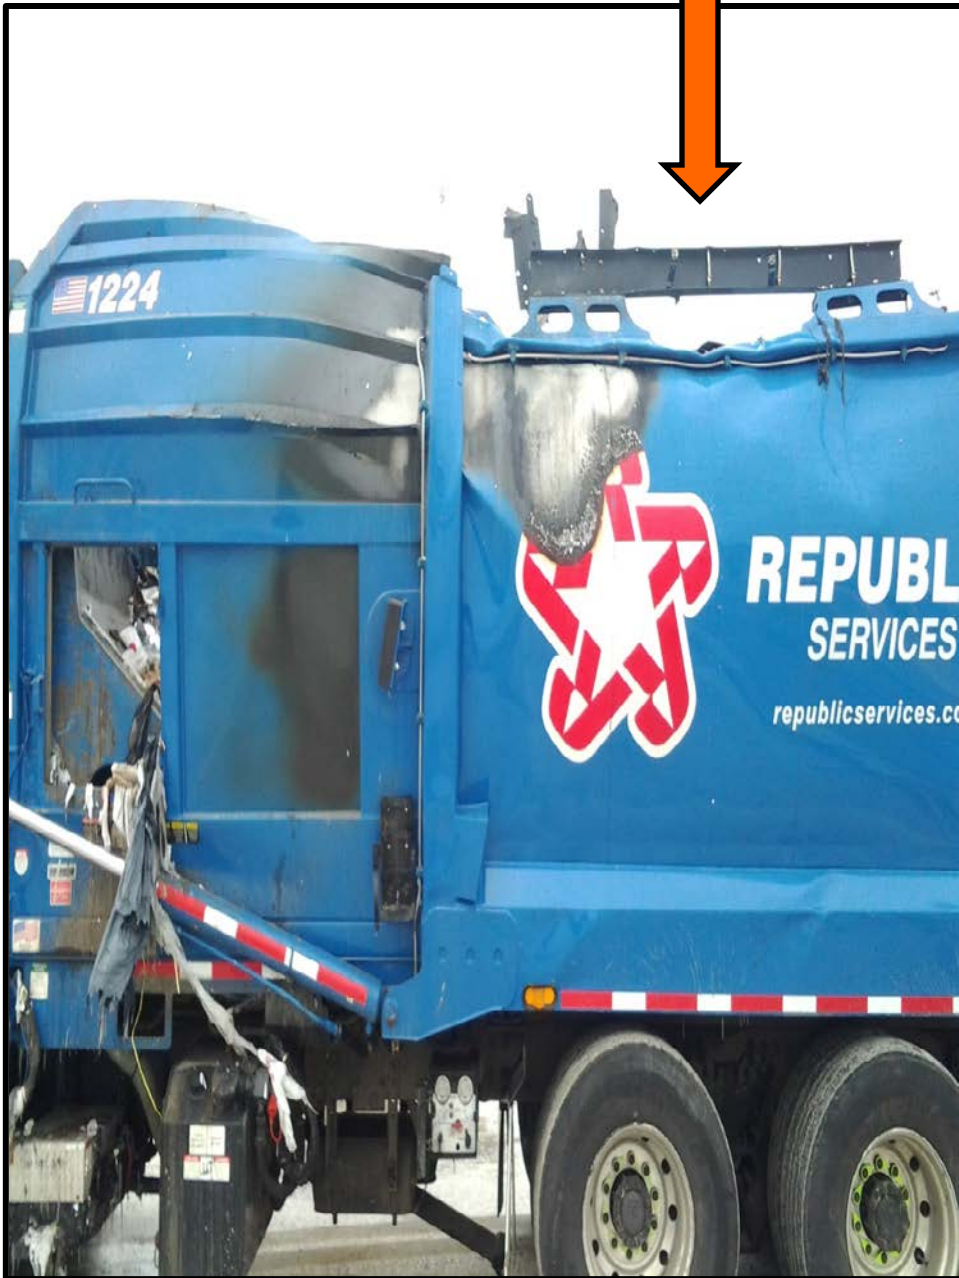
# Location of remaining frame rails of fuel cells (cascade POD)

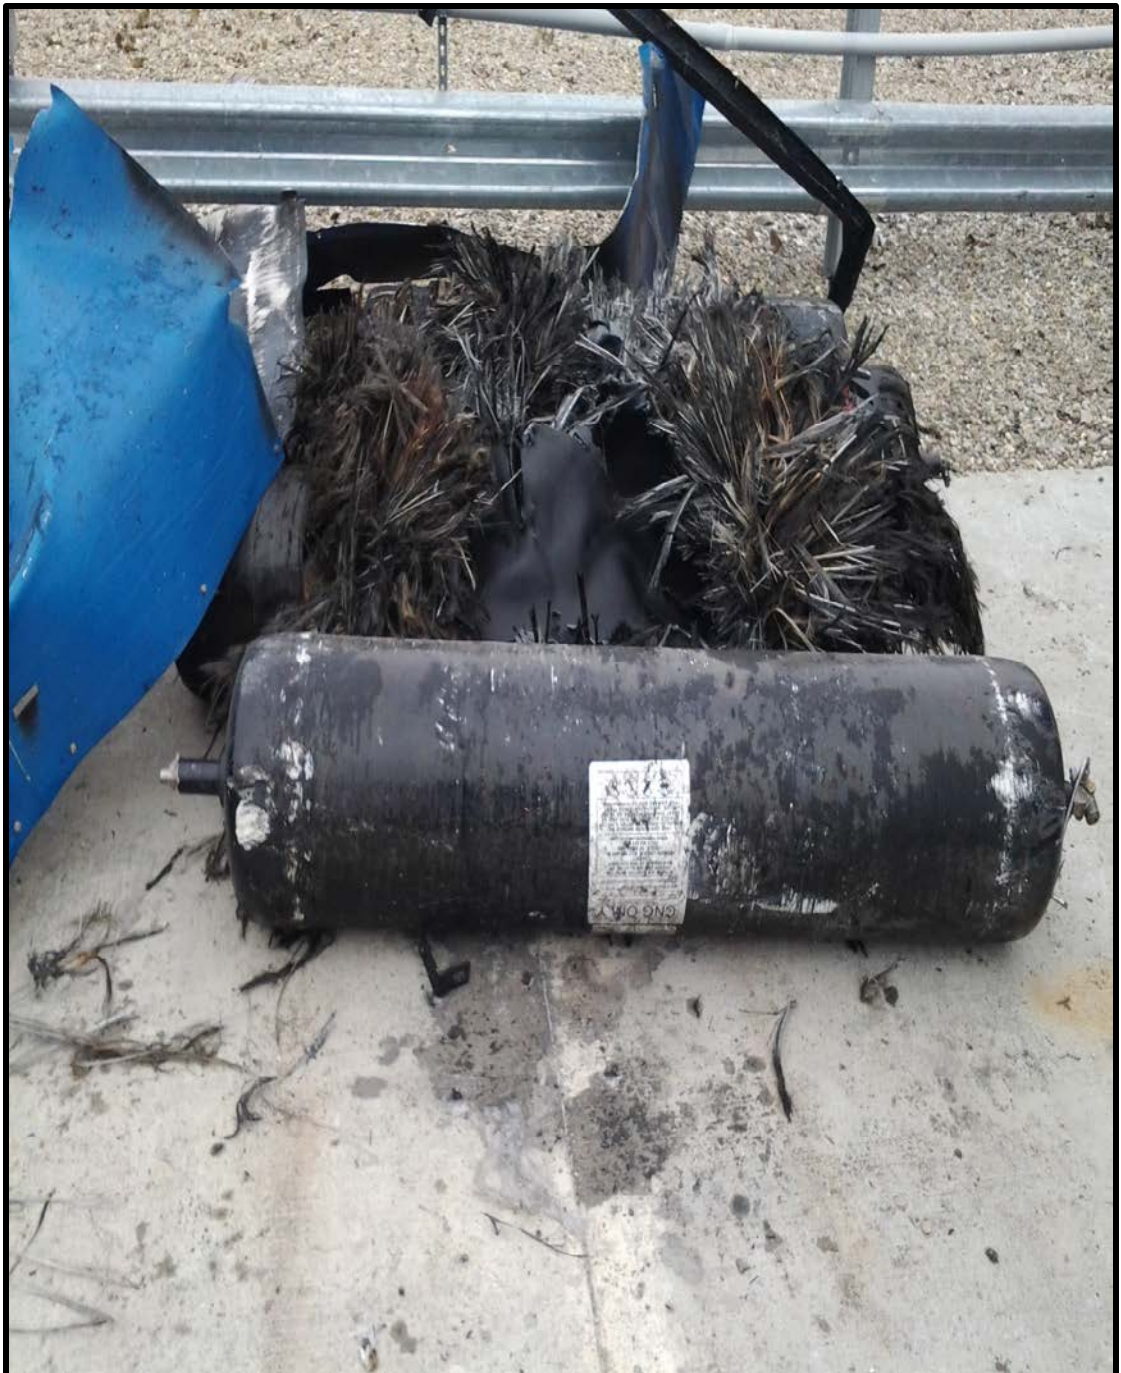
# Exploded cylinders

The two cylinders that exploded.  
Both failed near the middle of the  
tanks, it is presumed in the area of  
flame impingement.

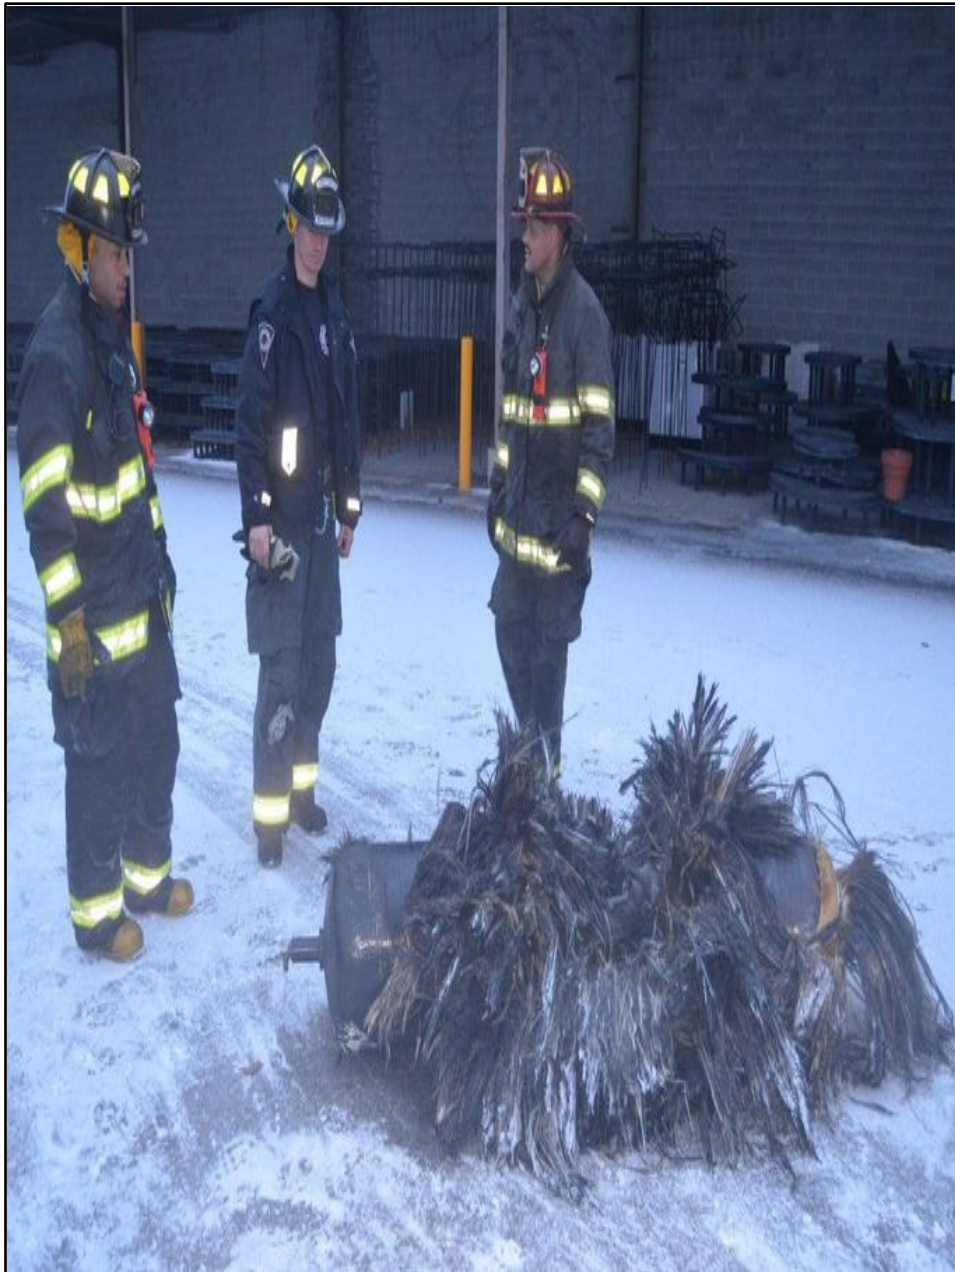
This picture taken at the scene gives some idea as to the size/scale of the tanks that exploded.

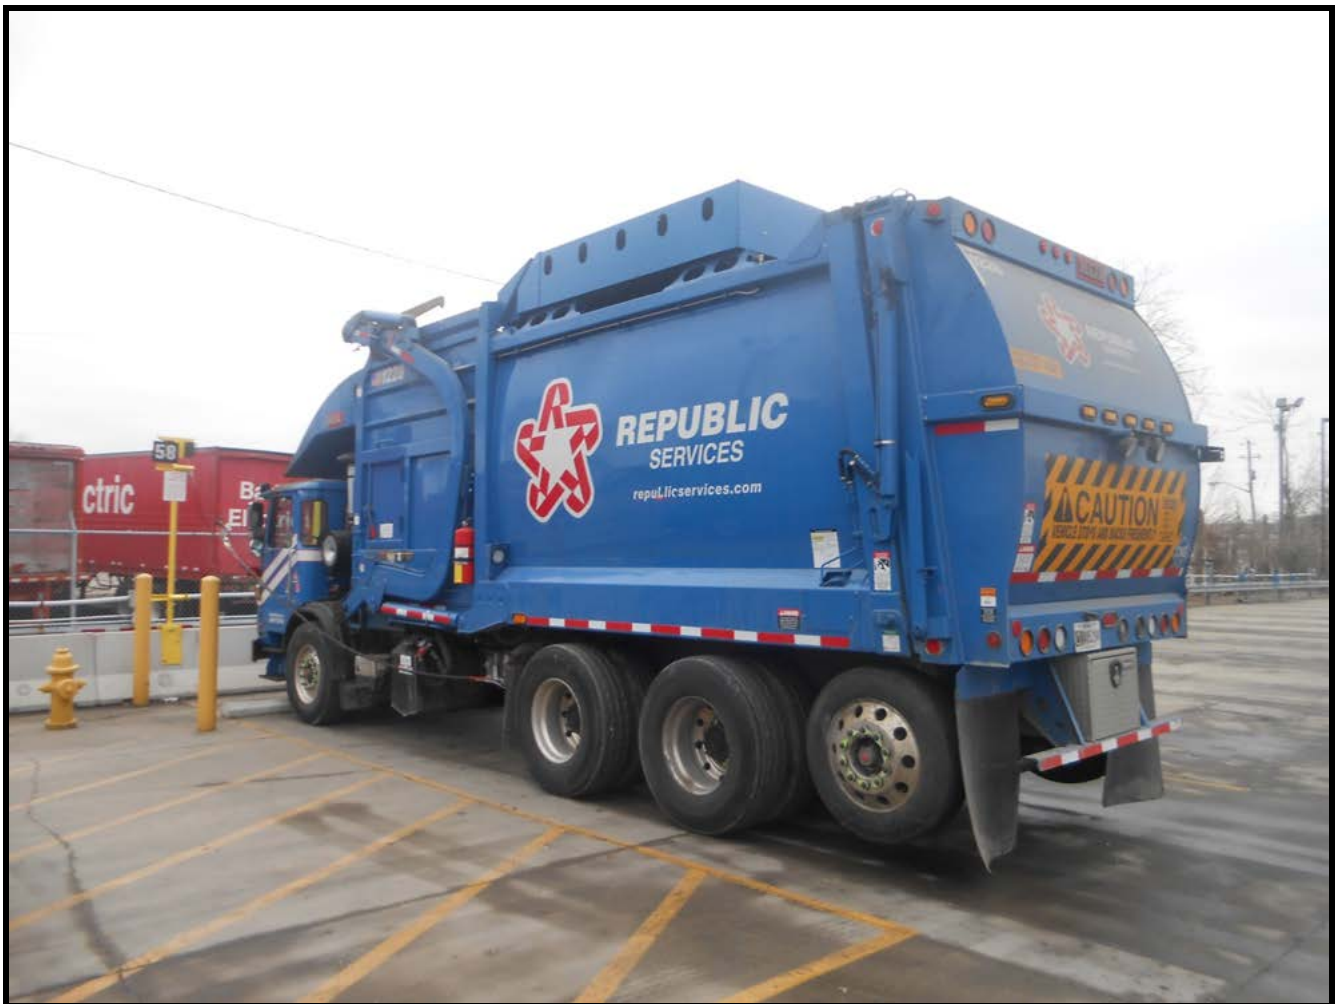
Example of truck without damage.  
Notice cascade POD cover on top.

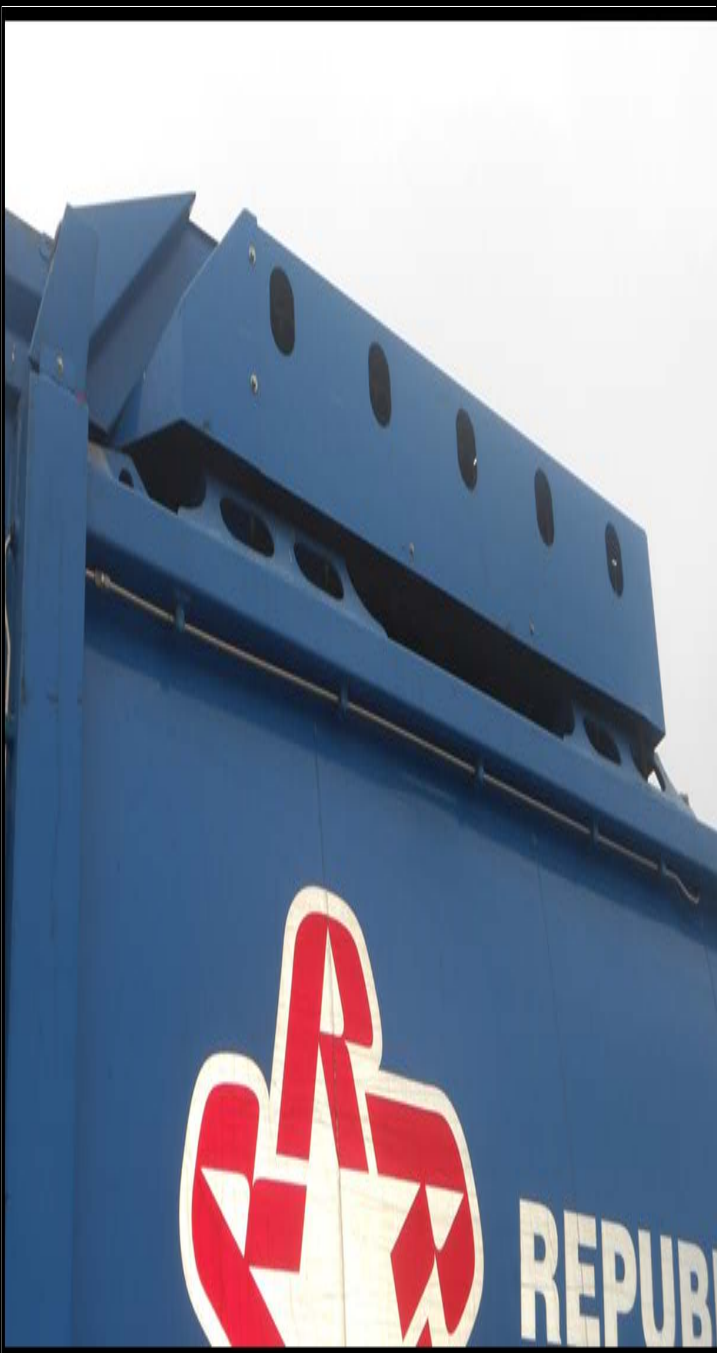
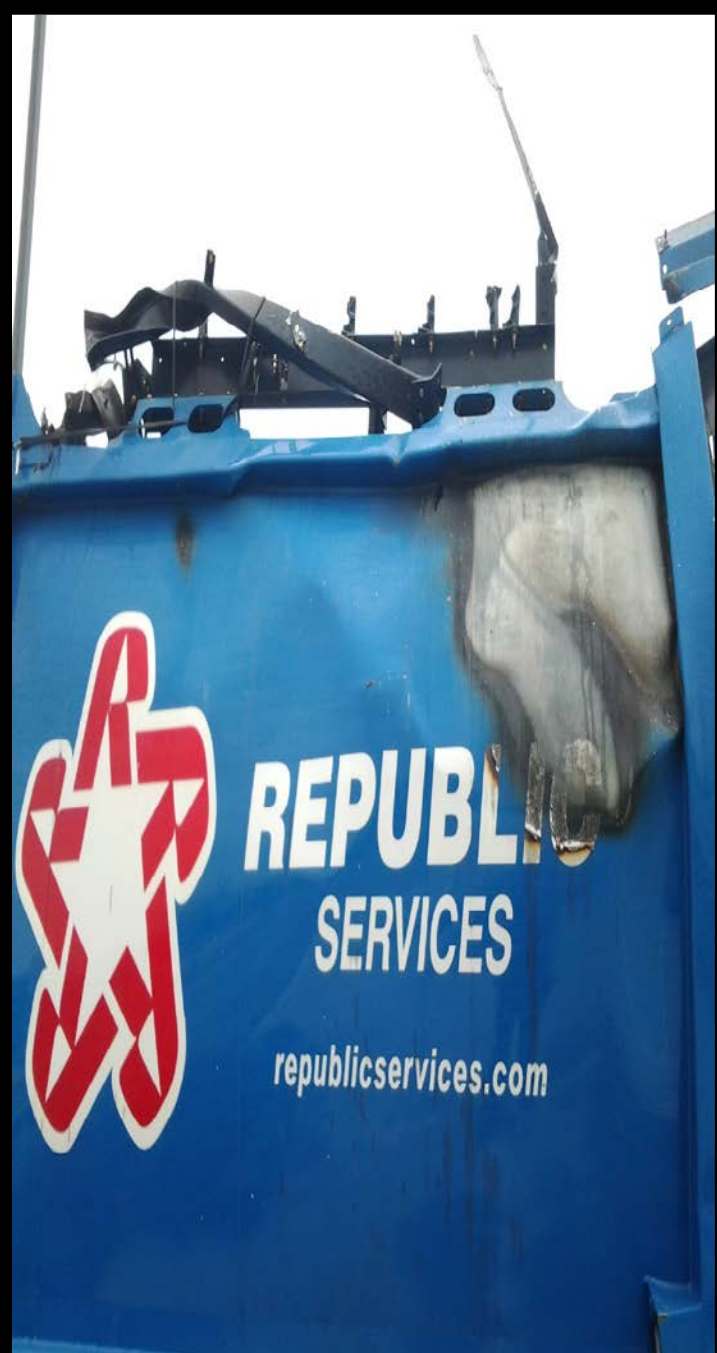
# Comparison of damage .

Example of truck after explosion with extensive damage.

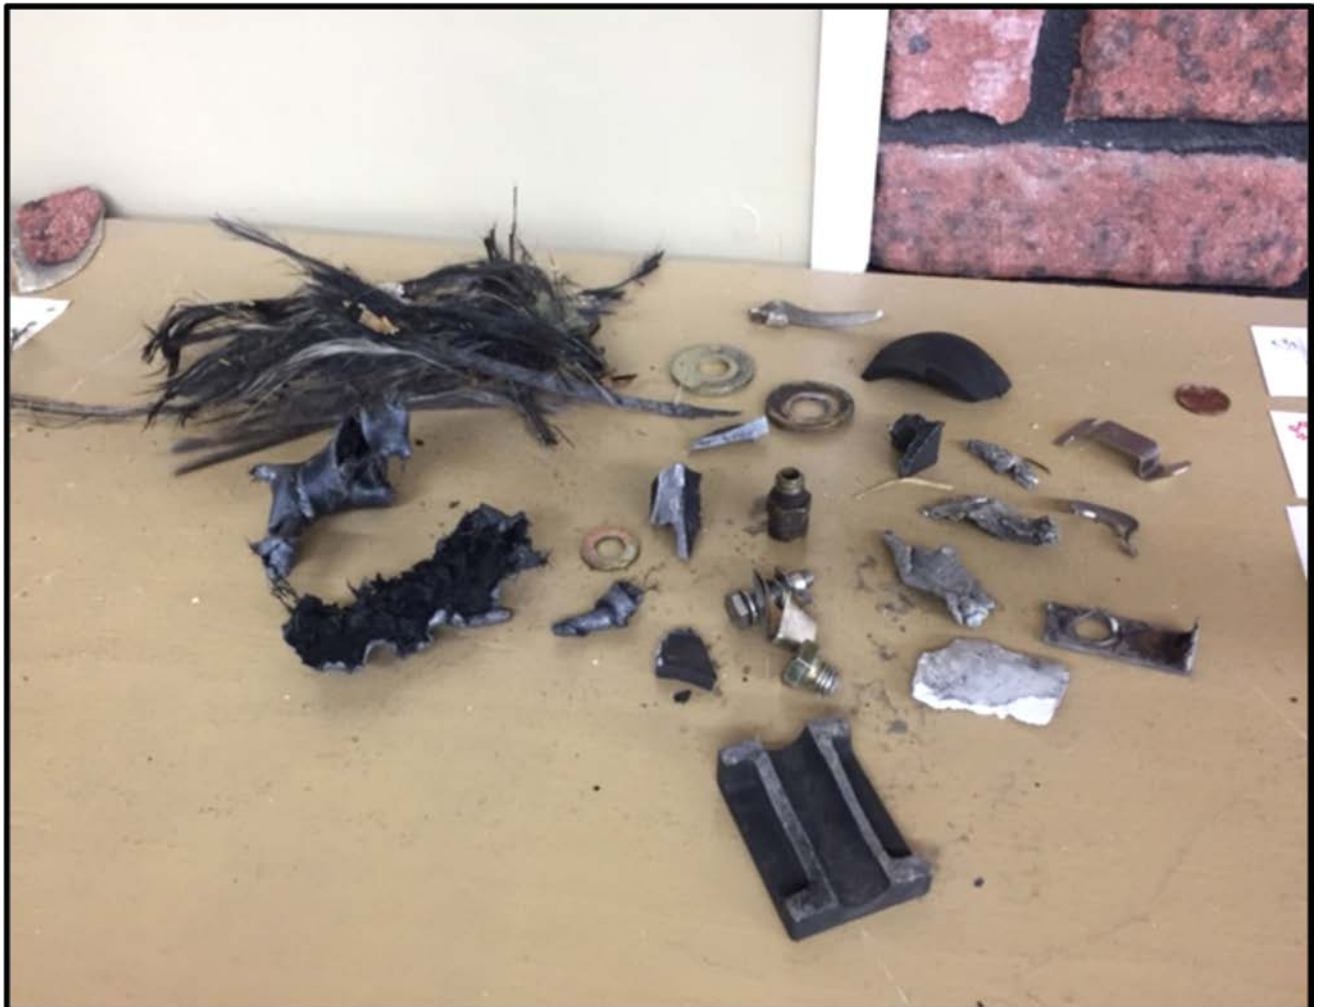
Found in parking lot of *Everyday Paint and Wallpaper*, 8512 Westfield Blvd., to the north of scene

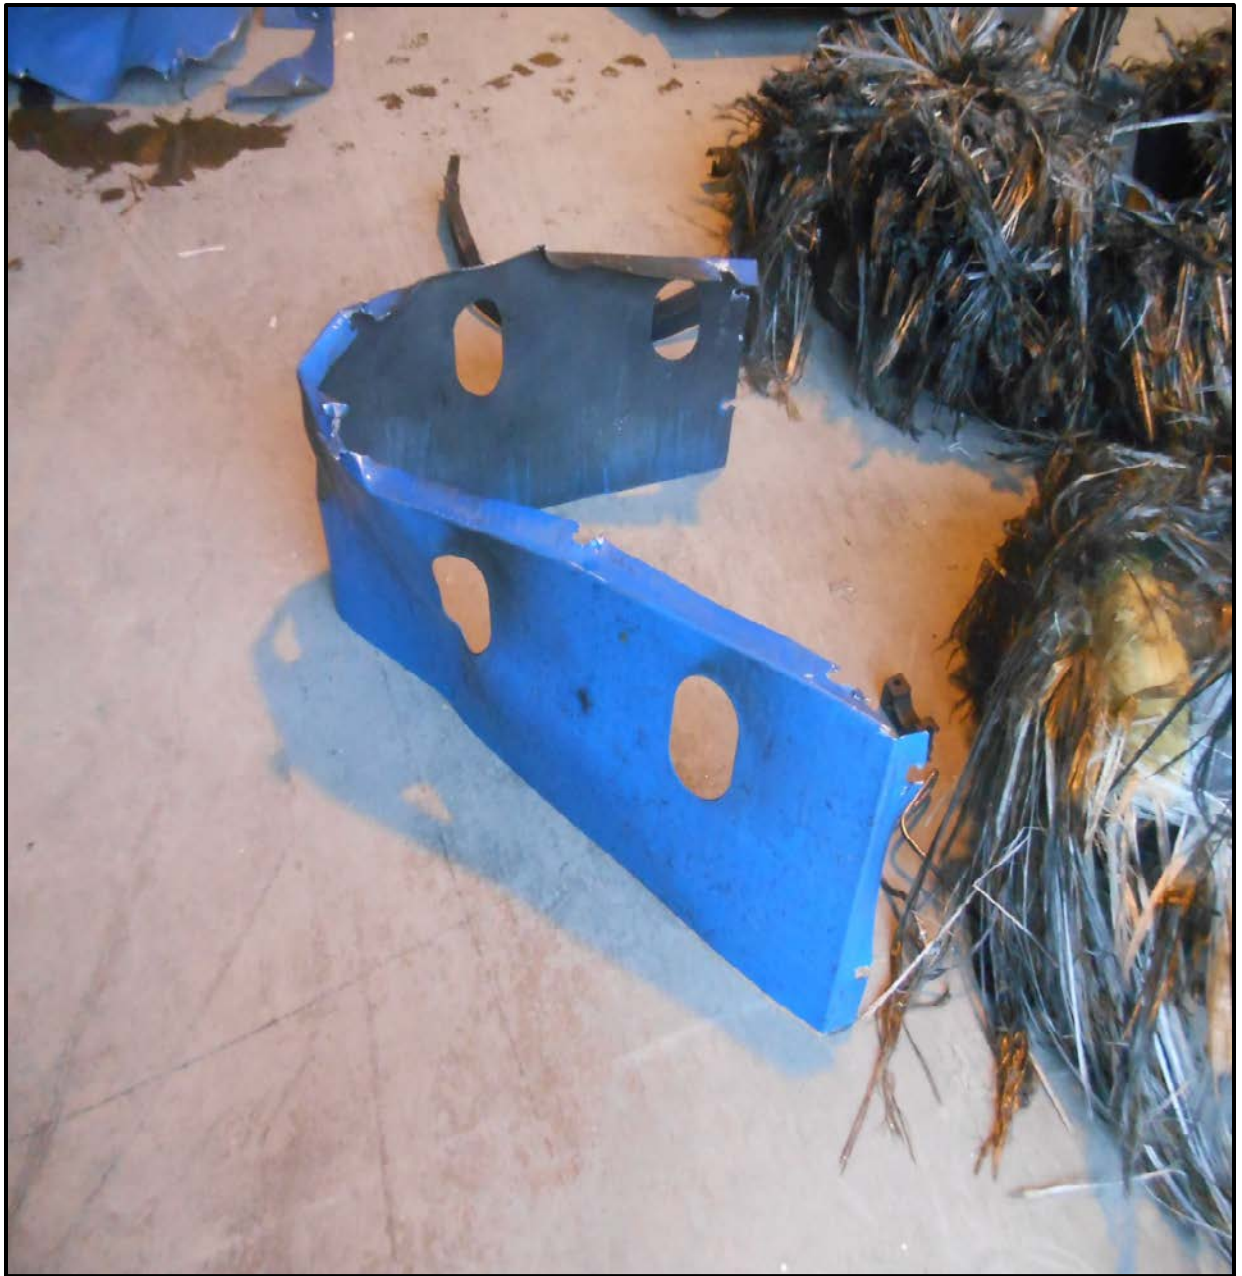
# 10-gauge steel sheet metal from side of cascade POD cover

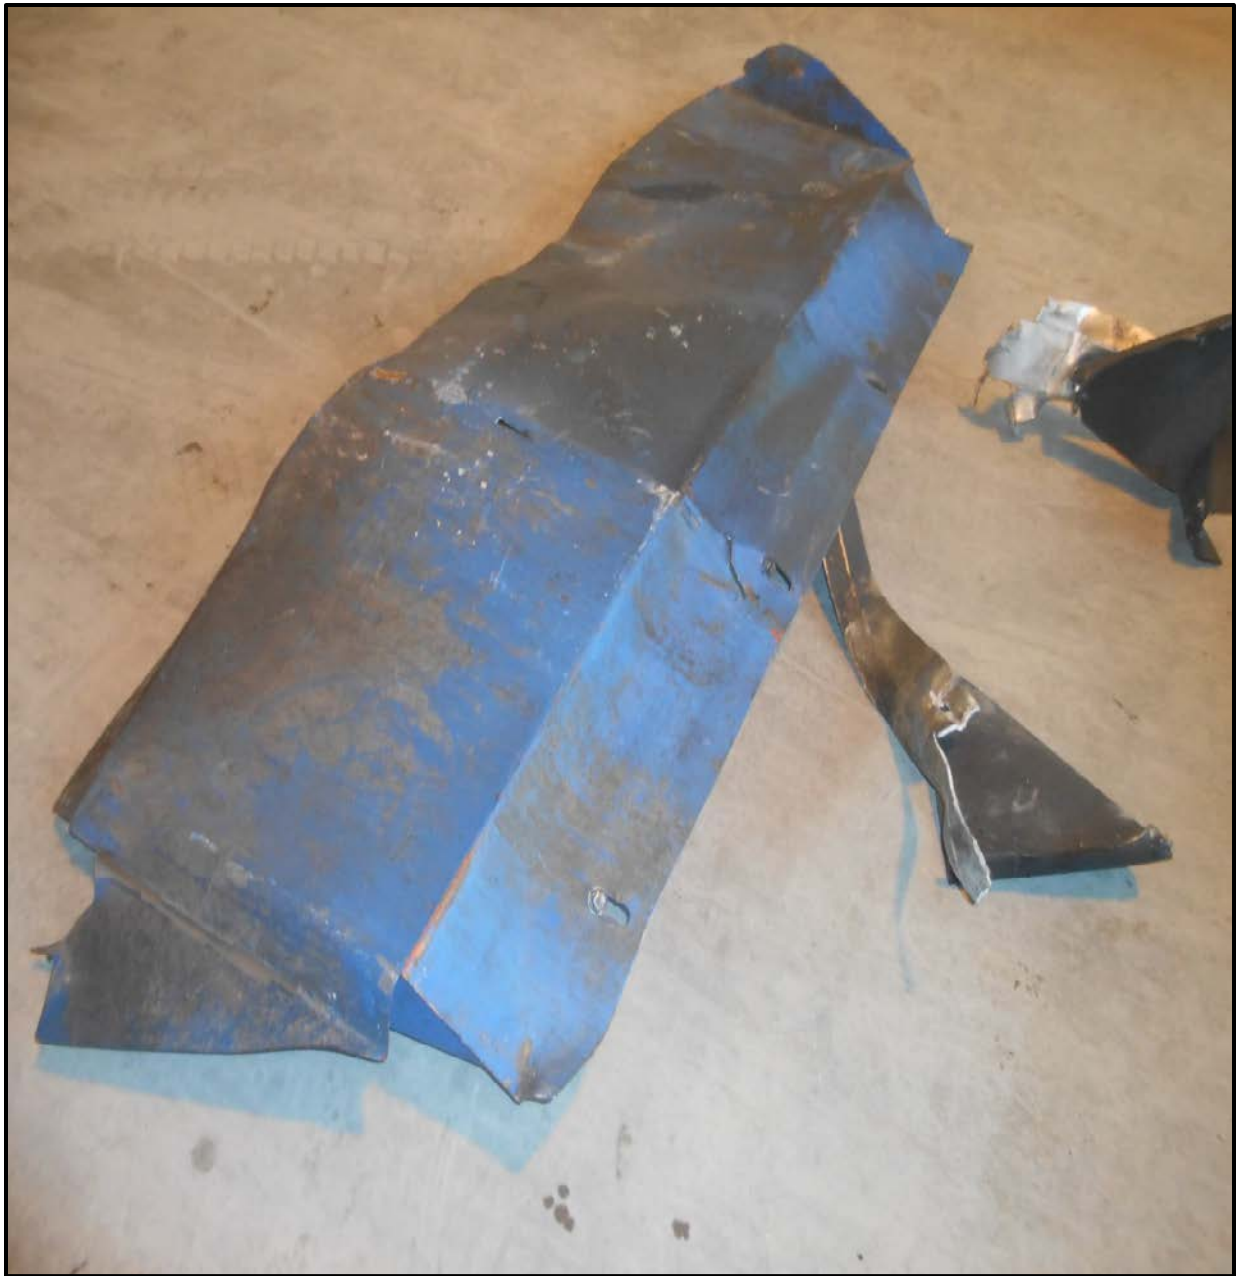
10-gauge steel sheet metal  
from cascade POD cover

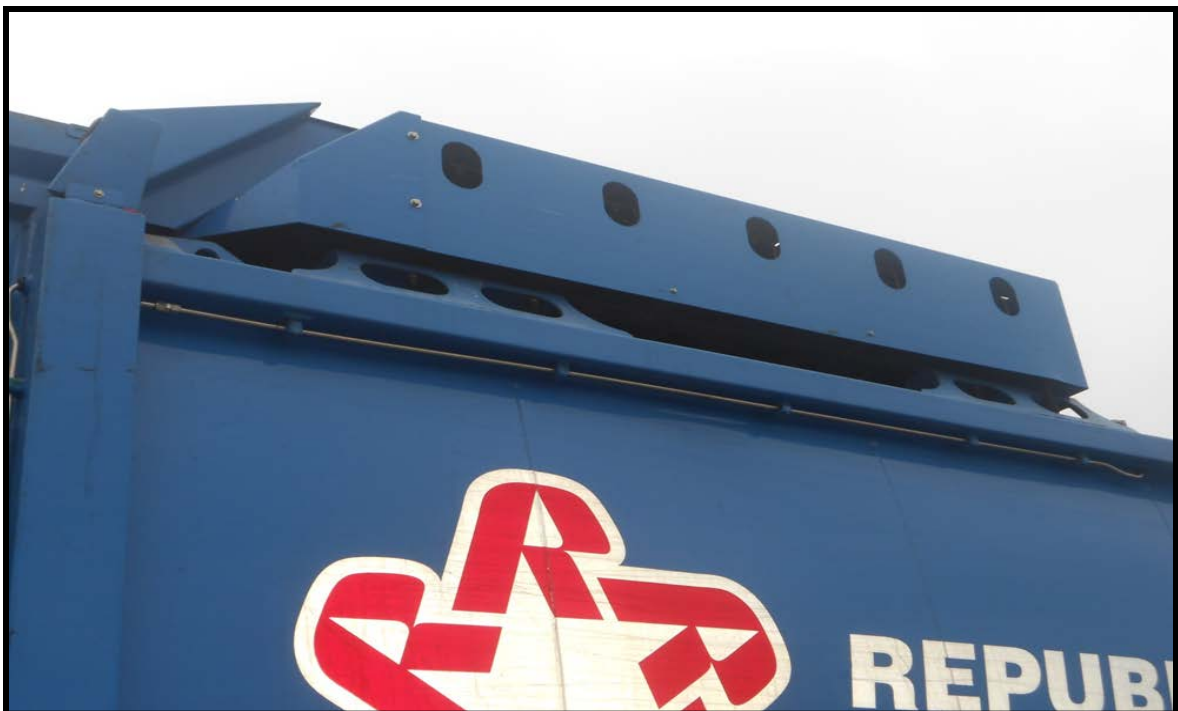
The CNG (Compressed Natural Gas) Type-4 cylinders were located directly above the body of the truck where the fire was located.

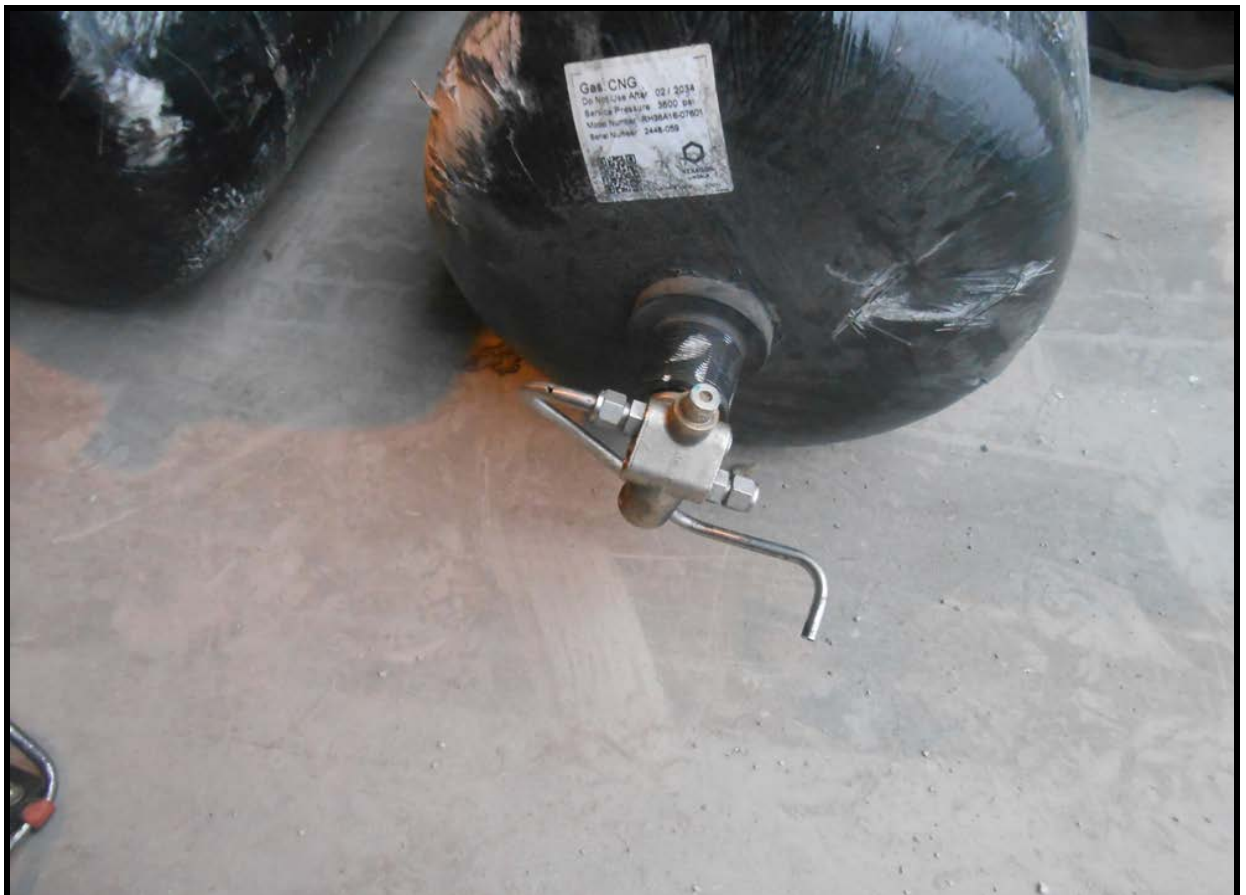
Temperature Sensitive Pressure Relief Device (PRD) located at each end of the cylinder.

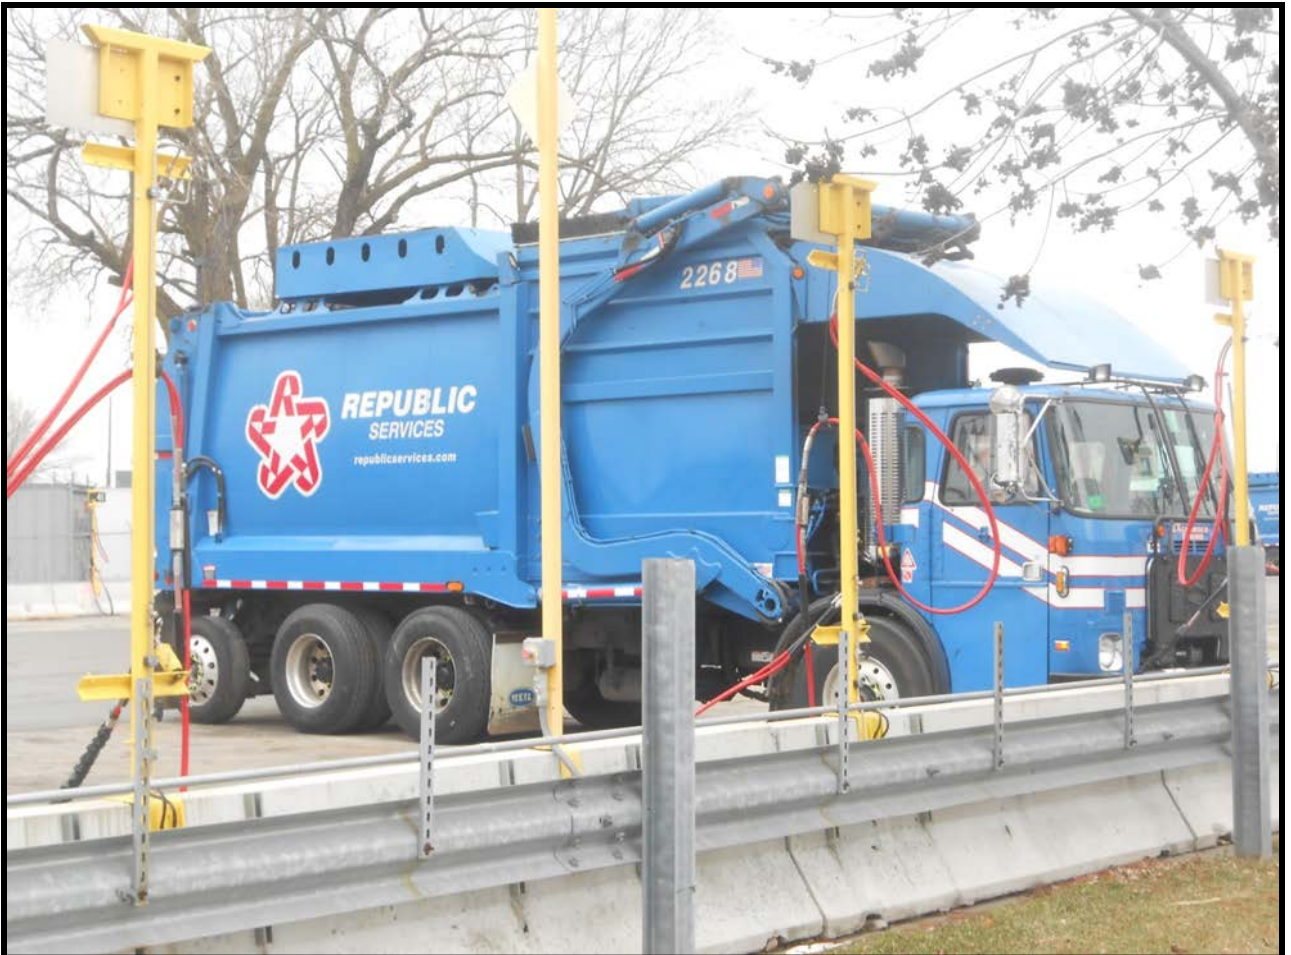
CNG propelled garbage truck  
attached to filling hoses.

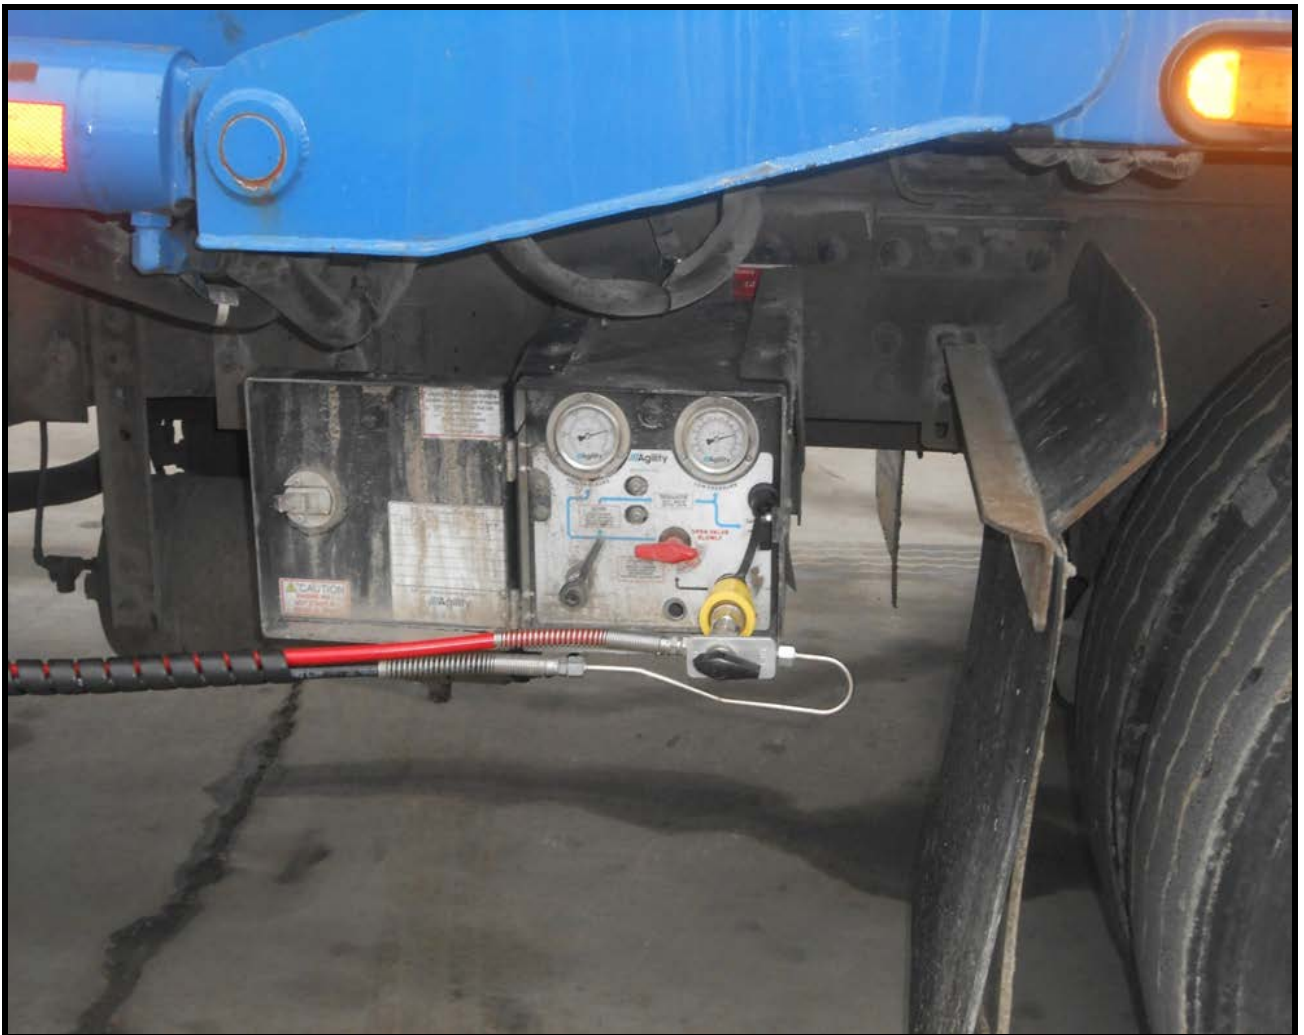
CNG control valves.

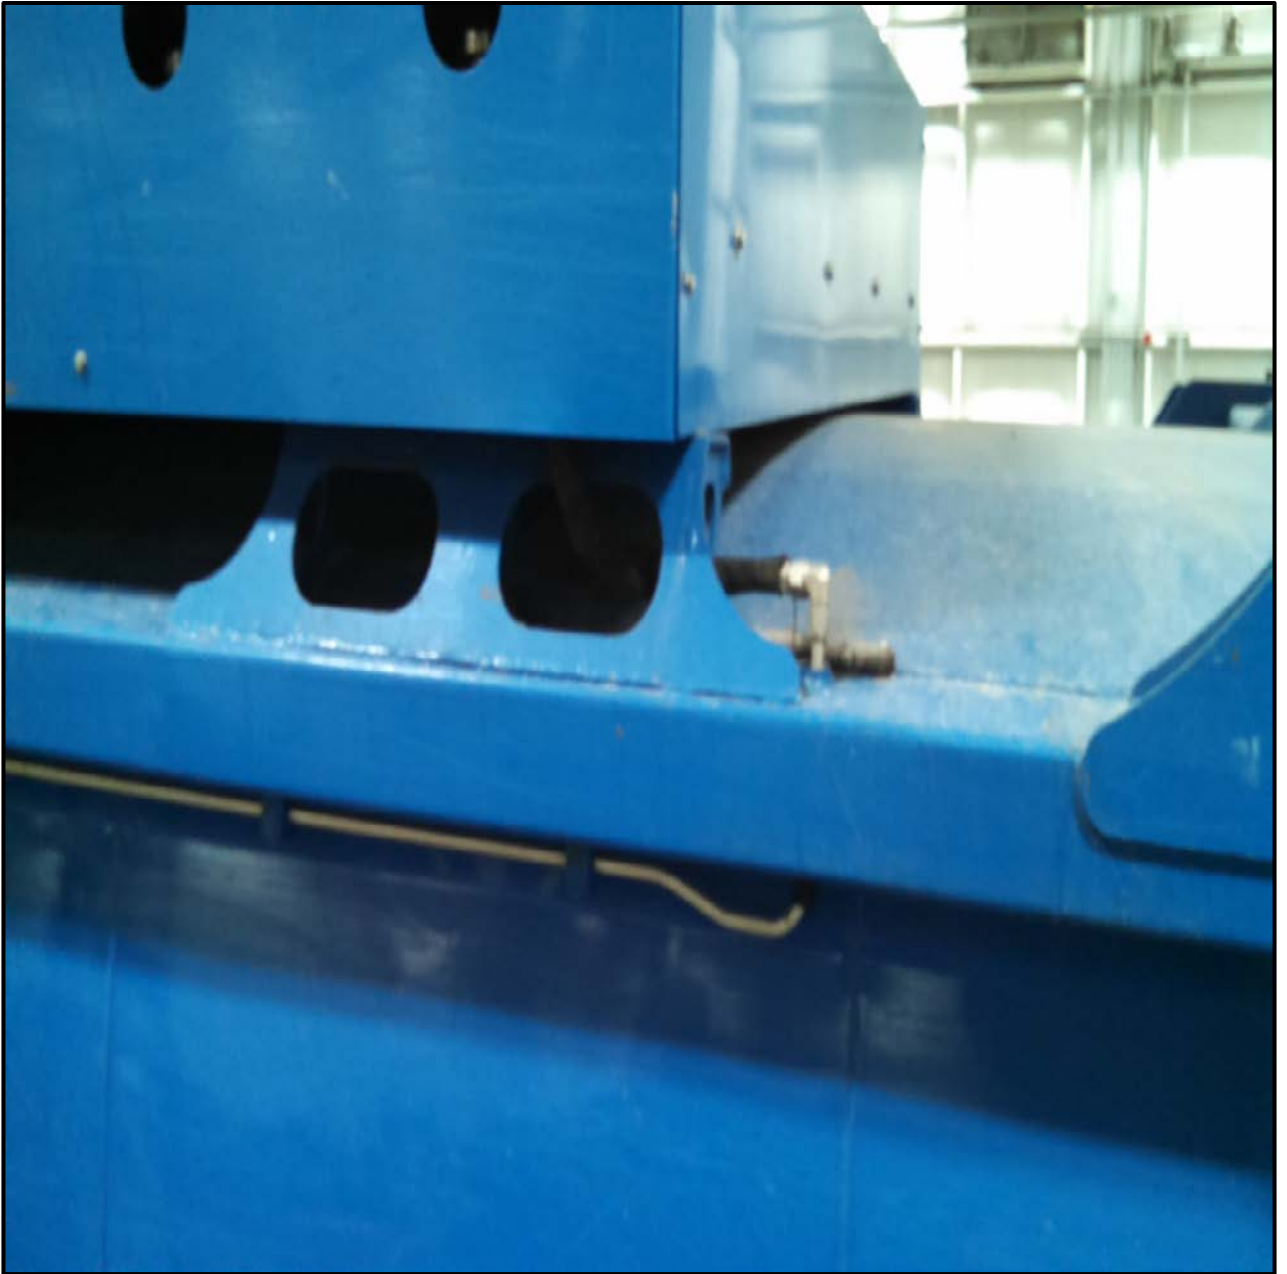
# Fuel line exiting the “POD”
